Access Compliance Report

Public Rights-of-Way

(Curb Ramps)

Intersection ID: 18036	Main Street: INWOOD_DR	Cross Street: SOUTH_BV	Location: SW
ADA ID: 5175D2F1164C	Ramp Type: PerpDiag	Initial Pass/Fail: Fail	Overall Compliance: No
Severity Score: 12.5			
Codes/Mitigation Info/Possible Solution		Field Measurements/Component Compliance

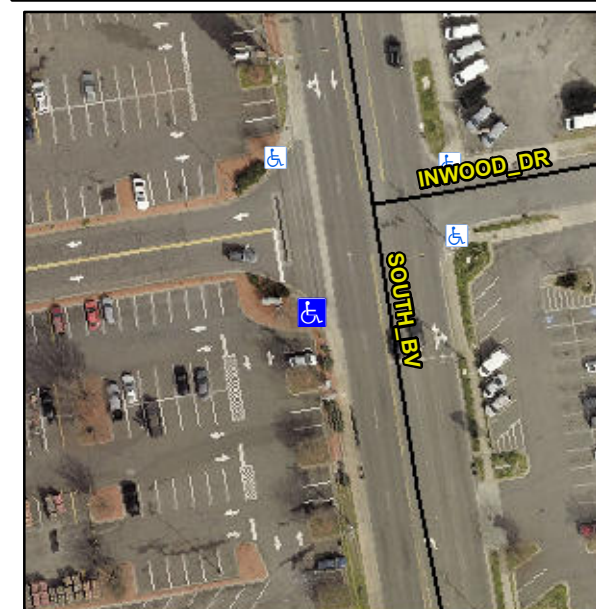
PROW/ADA:

Not Found, R304.5.3

Compliance	Description	Data	Compliance	Description	Data
N/A	Ramp Length (in)	48.0	Yes	Ramp Slope (%)	5.3
Yes	Ramp Width (in)	48.0	No	Ramp XSlope (%)	6.2
N/A	Flare Type LT	N/A	N/A	Flare Type RT	N/A
N/A	Flare Slope LT (%)	N/A	N/A	Flare Slope RT (%)	N/A
N/A	Flare Traversable LT?	N/A	N/A	Flare Traversable RT?	N/A
N/A	Landing Length (in)	N/A	N/A	DWS Provided?	N/A
N/A	Landing Width (in)	N/A	N/A	DWS Contrast?	N/A
N/A	Landing Slope (%)	N/A	N/A	DWS Length (in)	N/A
N/A	Landing X Slope (%)	N/A	N/A	DWS Full Width?	N/A
N/A	Landing Curb? (Y/N)	N/A	N/A	DWS Offset (in)	N/A
N/A	Shared Landing?	N/A			
N/A	Gutter Ponding?	N/A	N/A	Gutter Slope (%)	N/A
N/A	Gutter Lip Ht (in)	N/A	N/A	Gutter X Slope (%)	N/A
N/A	Painted X Walk1?	No	N/A	Painted X Walk2?	No
	X Walk 1 Direction	To NE		X Walk 2 Direction	To N
N/A	X Walk 1 Width (in)	N/A	N/A	X Walk 2 Width (in)	N/A
	X Walk 1 Slope (%)	9.2		X Walk 2 Slope (%)	1.1
	X Walk 1 X Slope (%)	1.4		X Walk 2 X Slope (%)	8.4

N/A	Ramp inside XWalk1?	N/A	N/A	Ramp inside XWalk2?	N/A
	Road Slope (%)	9.0	N/A	Clear Space?	N/A
	Road X Slope (%)	6.3	N/A	Clear Space to XWalk (in)	N/A
N/A	Any Obstructions?	N/A	N/A	Storm Grate/Utility Hazard?	N/A
	Obstruction Type			Storm Grate/Utility Type	
		N/A			N/A
		Yes		Surface Condition? (G/P)	Good

Possible Solutions:

Remove & Replace Curb Ramp With Two New Directional Ramps or Equivalent.
