# Access Compliance Report

## Public Rights-of-Way

### (Curb Ramps)

| Intersection ID: 9543 | Main Street: W_30TH_ST | Cross Street: BELLEFONTE_DR | Location: SW |

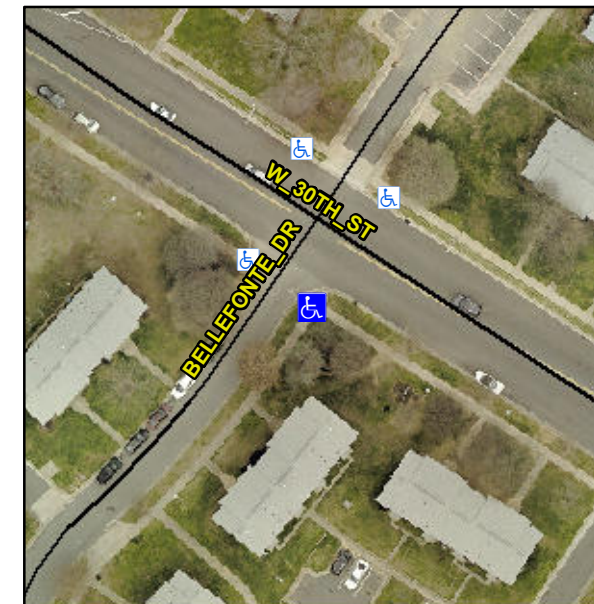
| ADA ID: 5178FC2EE692 | Ramp Type: PerpDiag | Initial Pass/Fail: Fail | Overall Compliance: No |

**Not Found, R304.5.1, R304.5.3**

| Compliance | Description | Data | Compliance | Description | Data |
|---|---|---|---|---|---|
| No | Ramp Width (in) | 40.5 | No | Ramp XSlope (%) | 3.0 |

**Remove & Replace Curb Ramp With Two New Directional Ramps or Equivalent.**

Total Cost: \$ 3200.00
