Access Compliance Report

Public Rights-of-Way

(Curb Ramps)

Intersection ID: 10032717	Main Street: N_POPLAR_ST	Cross Street: N/A	Location: N
ADA ID: 51819FEE6D20	Ramp Type: Directional1	Initial Pass/Fail: Fail	Overall Compliance: No
Codes/Mitigation Info/Possible Solution		Field Measurements/Component Compliance	
Severity Score: 8.75

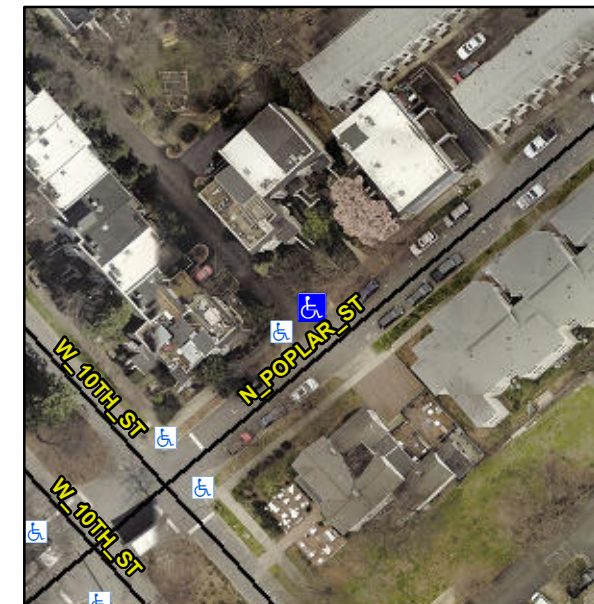
Compliance	Description	Data	Compliance	Description	Data
N/A	Ramp Length (in)	56.0	N/A	Grade Break?	N/A
No	Ramp Width (in)	42.0	N/A	Grade Break Slope (%)	0.0
Yes	Ramp Slope (%)	2.1	N/A	Grade Break XSlope (%)	0.0
Yes	Ramp XSlope (%)	1.5			
N/A	Flare Type LT	N/A	N/A	Flare Type RT	N/A
N/A	Flare Slope LT (%)	N/A	N/A	Flare Slope RT (%)	0.0
N/A	Flare Traversable LT?	N/A	N/A	Flare Traversable RT?	N/A
N/A	Landing Length (in)	0.0	N/A	DWS Provided?	N/A
N/A	Landing Width (in)	0.0	N/A	DWS Contrast?	N/A
N/A	Landing Slope (%)	0.0	N/A	DWS Length (in)	N/A
N/A	Landing X Slope (%)	0.0	N/A	DWS Full Width?	N/A
N/A	Landing Curb? (Y/N)	N/A	N/A	DWS Offset LT (in)	N/A
N/A	Shared Landing?	N/A	N/A	DWS Offset RT (in)	N/A
N/A	Gutter Ponding?	0.0	N/A	Gutter Slope (%)	N/A
N/A	Gutter Lip Ht (in)	0.0	N/A	Gutter X Slope (%)	N/A
N/A	Painted X Walk1?	No		Road Slope (%)	4.0
	X Walk 1 Direction	To SW		Road X Slope (%)	0.9
	X Walk 1 Width (in)	N/A		Clear Space?	N/A

X Walk 1 Slope (%)	4.0	N/A	Clear Space to XWalk (in)	N/A
	X Walk 1 X Slope (%)	0.9	N/A	Storm Grate/Utility Hazard?	N/A
N/A	Ramp inside XWalk1?	N/A		Storm Grate/Utility Type	
N/A	Any Obstructions?	N/A			N/A
	Obstruction Type		Yes	Surface Condition? (G/P)	Good
			N/A	Curb Slope (%)	2.6

Possible Solutions:

Remove & Replace Entire Ramp.
