Access Compliance Report Public Rights-of-Way (Curb Ramps)

Intersection ID: 31764 Main Street: CAROB TREE LN **Cross Street: STARNES RANDALL RD** Location: NW ADA ID: 5190E99D5B78 Ramp Type: PerpDiag Initial Pass/Fail: Pass **Overall Compliance: No Severity Score:** 0.25

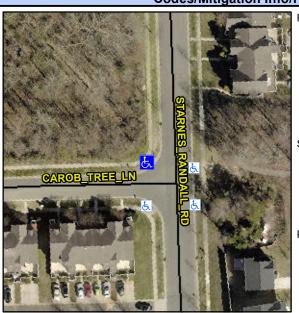
Compliance Description		Data	Compliance Description		Data
N/A	Ramp Length (in)	87.5	Yes	Ramp Slope (%)	7.4
Yes	Ramp Width (in)	48.0	No	Ramp XSlope (%)	3.4
N/A	Flare Type LT	Sloped	N/A	Flare Type RT	N/A
N/A	Flare Slope LT (%)	3.1	Yes	Flare Slope RT (%)	8.5
N/A	Flare Traversable LT?	Yes	N/A	Flare Traversable RT?	Yes
Yes	Landing Length (in)	48.0	Yes	DWS Provided?	Yes
Yes	Landing Width (in)	48.0	Yes	DWS Contrast?	Yes
No	Landing Slope (%)	4.0	Yes	DWS Length (in)	24.0
No	Landing X Slope (%)	2.8	Yes	DWS Full Width?	Yes
N/A	Landing Curb? (Y/N)	No	Yes	DWS Offset (in)	0.0
N/A	Shared Landing?	Yes			
Yes	Gutter Ponding?	No	Yes	Gutter Slope (%)	5.0
Yes	Gutter Lip Ht (in)	0.0	No	Gutter X Slope (%)	3.5
N/A	Painted X Walk1?	No	N/A	Painted X Walk2?	No
	X Walk 1 Direction	To S		X Walk 2 Direction	To E
N/A	X Walk 1 Width (in)	N/A	N/A	X Walk 2 Width (in)	N/A
	X Walk 1 Slope (%)	1.3		X Walk 2 Slope (%)	2.7
	X Walk 1 X Slope (%)	2.5		X Walk 2 X Slope (%)	1.6

N/A	Ramp inside XWalk1?	N/A	N/A	Ramp inside XWalk2?	N/A
	Road Slope (%)	2.8	N/A	Clear Space?	Yes
	Road X Slope (%)	0.7	N/A	Clear Space to XWalk (in)	N/A
Yes	Any Obstructions?	No	Yes	Storm Grate/Utility Hazard?	No
	Obstruction Type			Storm Grate/Utility Type	
		N/A			N/A
			I

CAROB TREE LN StopSign STARNES RANDALL RD None Possible Solutions: Remove & Replace Curb Ramp With Two New Directional Ramps or Equivalent. Remove & Replace Gutter. Surveyor Notes: N/A

Not Found, R304.5.3, R304.2.2-Perp, R304.3.2-Para

Total Cost: 3950.00
