Access Compliance Report

Public Rights-of-Way

(Curb Ramps)

Intersection ID: 24585	Main Street: REA_CROFT_DR	Cross Street: REA_RD	Location: SE
ADA ID: 519B776D9DFD	Ramp Type: Perp	Initial Pass/Fail: Fail	Overall Compliance: No
Codes/Mitigation Info/Possible Solution			Severity Score: 10
			Field Measurements/Component Compliance

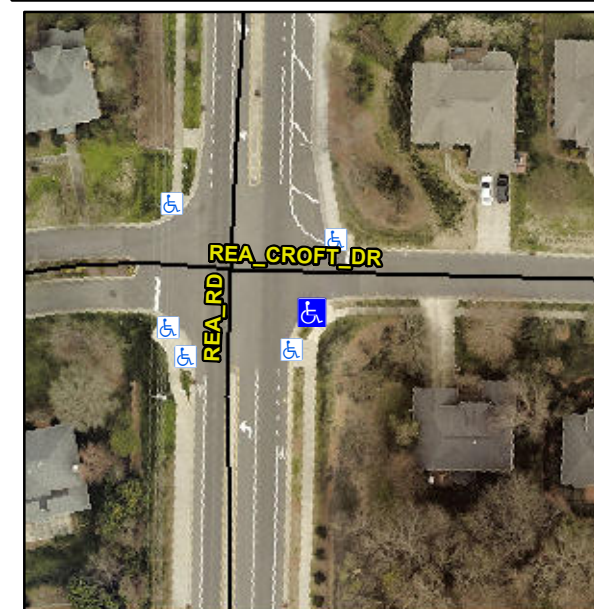
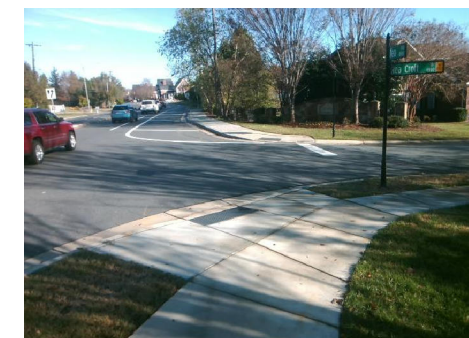
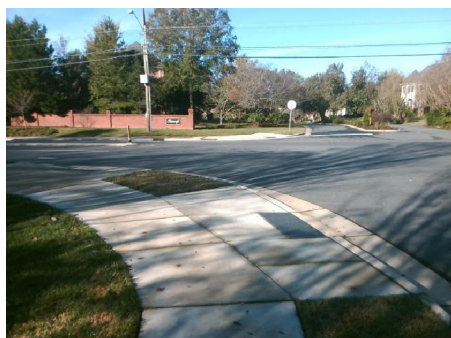
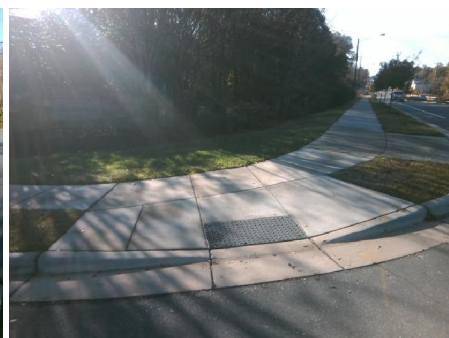
Compliance	Description	Data	Compliance	Description	Data
N/A	Ramp Length (in)	61.0	Yes	Ramp Slope (%)	6.6
No	Ramp Width (in)	47.0	No	Ramp XSlope (%)	3.8
N/A	Flare Type LT	N/A	N/A	Flare Type RT	N/A
N/A	Flare Slope LT (%)	N/A	N/A	Flare Slope RT (%)	N/A
N/A	Flare Traversable LT?	N/A	N/A	Flare Traversable RT?	N/A
N/A	Landing Length (in)	N/A	N/A	DWS Provided?	N/A
N/A	Landing Width (in)	N/A	N/A	DWS Contrast?	N/A
N/A	Landing Slope (%)	N/A	N/A	DWS Length (in)	N/A
N/A	Landing X Slope (%)	N/A	N/A	DWS Full Width?	N/A
N/A	Landing Curb? (Y/N)	N/A	N/A	DWS Offset (in)	N/A
N/A	Shared Landing?	N/A			
N/A	Gutter Ponding?	N/A	N/A	Gutter Slope (%)	N/A
N/A	Gutter Lip Ht (in)	N/A	N/A	Gutter X Slope (%)	N/A
N/A	Painted X Walk1?	No	N/A	Painted X Walk2?	N/A
	X Walk 1 Direction	To NE		X Walk 2 Direction	N/A
N/A	X Walk 1 Width (in)	N/A	N/A	X Walk 2 Width (in)	N/A
	X Walk 1 Slope (%)	0.5		X Walk 2 Slope (%)	N/A
	X Walk 1 X Slope (%)	4.7		X Walk 2 X Slope (%)	N/A

N/A	Ramp inside XWalk1?	N/A	N/A	Ramp inside XWalk2?	N/A
	Road Slope (%)	N/A	N/A	Clear Space?	N/A
	Road X Slope (%)	N/A	N/A	Clear Space to XWalk (in)	N/A
N/A	Any Obstructions?	N/A	N/A	Storm Grate/Utility Hazard?	N/A
	Obstruction Type			Storm Grate/Utility Type	
		N/A			N/A
			Yes	Surface Condition? (G/P)	Good

Possible Solutions:

Remove & Replace Entire Ramp.

R304.5.1, R304.5.3
