Access Compliance Report

Public Rights-of-Way

(Curb Ramps)

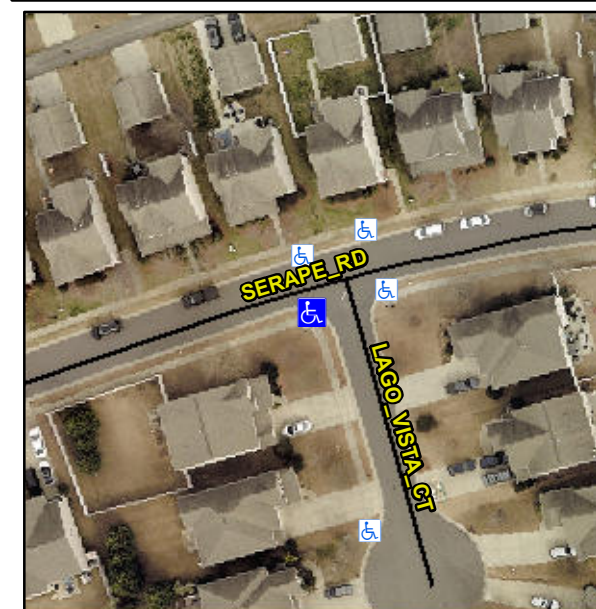
Intersection ID: 47850	Main Street: LAGO_VISTA_CT	Cross Street: SERAPE_RD	Location: SW
ADA ID: 519E8D46EEA4	Ramp Type: PerpDiag	Initial Pass/Fail: Fail	Overall Compliance: No
Severity Score: 21.25			
Codes/Mitigation Info/Possible Solution		Field Measurements/Component Compliance

Not Found, R304.5.1, R304.2.2

Compliance	Description	Data	Compliance	Description	Data
N/A	Ramp Length (in)	48.0	No	Ramp Slope (%)	8.9
No	Ramp Width (in)	44.0	Yes	Ramp XSlope (%)	1.5
N/A	Flare Type LT	N/A	N/A	Flare Type RT	N/A
N/A	Flare Slope LT (%)	N/A	N/A	Flare Slope RT (%)	N/A
N/A	Flare Traversable LT?	N/A	N/A	Flare Traversable RT?	N/A
N/A	Landing Length (in)	N/A	N/A	DWS Provided?	N/A
N/A	Landing Width (in)	N/A	N/A	DWS Contrast?	N/A
N/A	Landing Slope (%)	N/A	N/A	DWS Length (in)	N/A
N/A	Landing X Slope (%)	N/A	N/A	DWS Full Width?	N/A
N/A	Landing Curb? (Y/N)	N/A	N/A	DWS Offset (in)	N/A
N/A	Shared Landing?	N/A			
N/A	Gutter Ponding?	N/A	N/A	Gutter Slope (%)	N/A
N/A	Gutter Lip Ht (in)	N/A	N/A	Gutter X Slope (%)	N/A
N/A	Painted X Walk1?	No	N/A	Painted X Walk2?	No
	X Walk 1 Direction	To E		X Walk 2 Direction	To N
N/A	X Walk 1 Width (in)	N/A	N/A	X Walk 2 Width (in)	N/A
	X Walk 1 Slope (%)	0.8		X Walk 2 Slope (%)	0.8
	X Walk 1 X Slope (%)	2.1		X Walk 2 X Slope (%)	0.9

N/A	Ramp inside XWalk1?	N/A	N/A	Ramp inside XWalk2?	N/A
	Road Slope (%)	0.6	N/A	Clear Space?	N/A
	Road X Slope (%)	3.7	N/A	Clear Space to XWalk (in)	N/A
N/A	Any Obstructions?	N/A	N/A	Storm Grate/Utility Hazard?	N/A
	Obstruction Type			Storm Grate/Utility Type	
		N/A			N/A
		Yes		Surface Condition? (G/P)	Good

Possible Solutions:

Remove & Replace Curb Ramp With Two New Directional Ramps or Equivalent.
