# Access Compliance Report

## Public Rights-of-Way

### (Curb Ramps)

Intersection ID: 30006	Main Street: FULLERTON_CT	Cross Street: OAKBORO_LN	Location: SE
ADA ID: 51A73A41F726	Ramp Type: PerpDiag	Initial Pass/Fail: Fail	Overall Compliance: No
Severity Score: 25			
Codes/Mitigation Info/Possible Solution		Field Measurements/Component Compliance

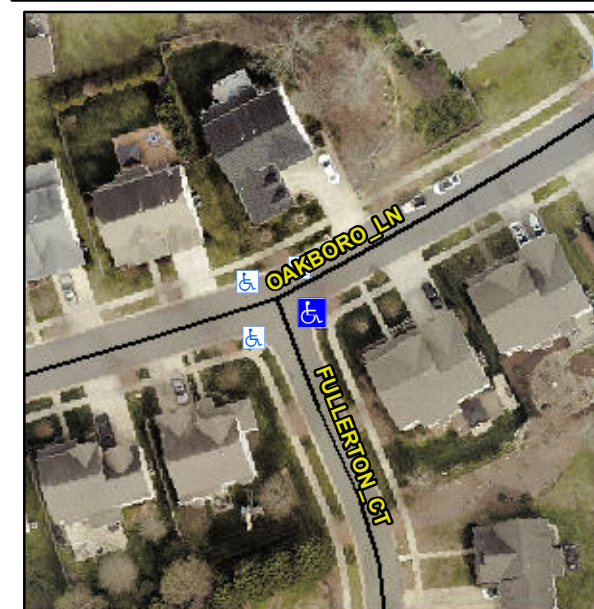
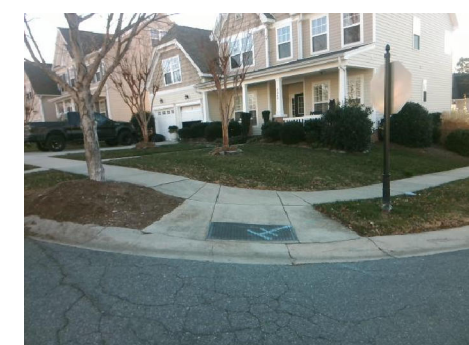
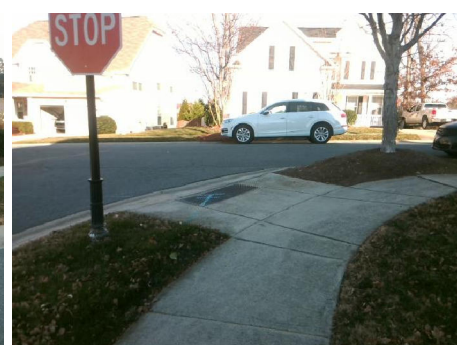
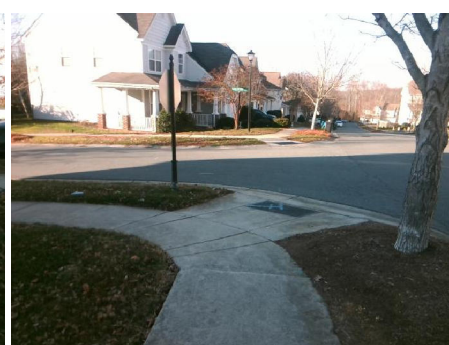
Compliance	Description	Data	Compliance	Description	Data
N/A	Ramp Length (in)	70.0	Yes	Ramp Slope (%)	7.0
Yes	Ramp Width (in)	48.0	No	Ramp XSlope (%)	11.2
N/A	Flare Type LT	N/A	N/A	Flare Type RT	N/A
N/A	Flare Slope LT (%)	N/A	N/A	Flare Slope RT (%)	N/A
N/A	Flare Traversable LT?	N/A	N/A	Flare Traversable RT?	N/A
N/A	Landing Length (in)	N/A	N/A	DWS Provided?	N/A
N/A	Landing Width (in)	N/A	N/A	DWS Contrast?	N/A
N/A	Landing Slope (%)	N/A	N/A	DWS Length (in)	N/A
N/A	Landing X Slope (%)	N/A	N/A	DWS Full Width?	N/A
N/A	Landing Curb? (Y/N)	N/A	N/A	DWS Offset (in)	N/A
N/A	Shared Landing?	N/A			
N/A	Gutter Ponding?	N/A	N/A	Gutter Slope (%)	N/A
N/A	Gutter Lip Ht (in)	N/A	N/A	Gutter X Slope (%)	N/A
N/A	Painted X Walk1?	No	N/A	Painted X Walk2?	No
	X Walk 1 Direction	To N		X Walk 2 Direction	To W
N/A	X Walk 1 Width (in)	N/A	N/A	X Walk 2 Width (in)	N/A
	X Walk 1 Slope (%)	3.8		X Walk 2 Slope (%)	1.2
	X Walk 1 X Slope (%)	5.3		X Walk 2 X Slope (%)	5.8

N/A	Ramp inside XWalk1?	N/A	N/A	Ramp inside XWalk2?	N/A
	Road Slope (%)	9.1	N/A	Clear Space?	N/A
	Road X Slope (%)	2.0	N/A	Clear Space to XWalk (in)	N/A
N/A	Any Obstructions?	N/A	N/A	Storm Grate/Utility Hazard?	N/A
	Obstruction Type			Storm Grate/Utility Type	
		N/A			N/A
			Yes	Surface Condition? (G/P)	Good

Possible Solutions:

**Remove & Replace Curb Ramp With Two New Directional Ramps or Equivalent.**

**Not Found, R304.5.3**

Total Cost: \$ 3200.00
