Access Compliance Report Public Rights-of-Way (Curb Ramps)

Intersection ID: 7519 Main Street: TRIBUNE_DR Cross Street: AMOS HOARD RD Location: ADA ID: 51A884516F22 Ramp Type: Perp Initial Pass/Fail: Fail **Overall Compliance: No** Severity Score: 21.25

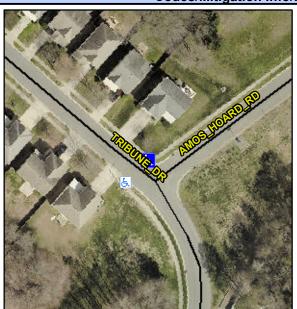
No	Ramp Width (in)	38.0	Yes	Ramp XSlope (%)	0.2
N/A	Flare Type LT	N/A	N/A	Flare Type RT	N/A
N/A	Flare Slope LT (%)	N/A	N/A	Flare Slope RT (%)	N/A
N/A	Flare Traversable LT?	N/A	N/A	Flare Traversable RT?	N/A
N/A	Landing Length (in)	N/A	N/A	DWS Provided?	N/A
N/A	Landing Width (in)	N/A	N/A	DWS Contrast?	N/A
N/A	Landing Slope (%)	N/A	N/A	DWS Length (in)	N/A
N/A	Landing X Slope (%)	N/A	N/A	DWS Full Width?	N/A
N/A	Landing Curb? (Y/N)	N/A	N/A	DWS Offset (in)	N/A
N/A	Shared Landing?	N/A			
N/A	Gutter Ponding?	N/A	N/A	Gutter Slope (%)	N/A
N/A	Gutter Lip Ht (in)	N/A	N/A	Gutter X Slope (%)	N/A
N/A	Painted X Walk1?	No	N/A	Painted X Walk2?	N/A
	X Walk 1 Direction	To SW		X Walk 2 Direction	N/A
N/A	X Walk 1 Width (in)	N/A	N/A	X Walk 2 Width (in)	N/A
	X Walk 1 Slope (%)	2.4		X Walk 2 Slope (%)	N/A
	X Walk 1 X Slope (%)	0.7		X Walk 2 X Slope (%)	N/A
N/A	Ramp inside XWalk1?	N/A	N/A	Ramp inside XWalk2?	N/A
	Road Slope (%)	N/A	N/A	Clear Space?	N/A

1	Possible Solutions:							
COMP.	Remove & Replace Entire Ramp.							
4								
1								
AND LOCAL								
Contract of the last	Surveyor Notes:							
200	N/A							
É	PROW/ADA:							
The same	Not Found, R304.5.1, R304.2.2
