Access Compliance Report

Public Rights-of-Way

(Curb Ramps)

Intersection ID: 54043	Main Street: ELEVATION_POINT_DR	Cross Street: BALLANTYNE_GREEN_DR	Location: NE
ADA ID: 51AA7CC1175A	Ramp Type: Directional1	Initial Pass/Fail: Fail	Overall Compliance: No
		Severity Score: 1.25

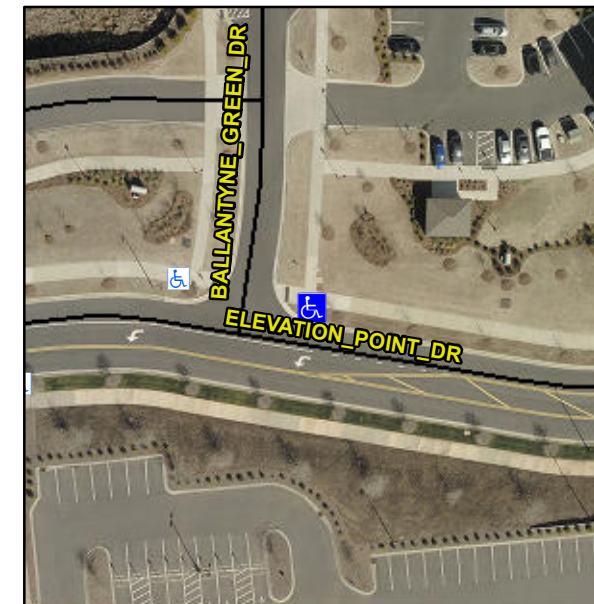
Compliance	Description	Data	Compliance	Description	Data
N/A	Ramp Length (in)	117.5	N/A	Grade Break?	N/A
Yes	Ramp Width (in)	96.0	N/A	Grade Break Slope (%)	0.0
Yes	Ramp Slope (%)	5.7	N/A	Grade Break XSlope (%)	0.0
No	Ramp XSlope (%)	2.2			
N/A	Flare Type LT	N/A	N/A	Flare Type RT	N/A
N/A	Flare Slope LT (%)	N/A	N/A	Flare Slope RT (%)	0.0
N/A	Flare Traversable LT?	N/A	N/A	Flare Traversable RT?	N/A
N/A	Landing Length (in)	0.0	N/A	DWS Provided?	N/A
N/A	Landing Width (in)	0.0	N/A	DWS Contrast?	N/A
N/A	Landing Slope (%)	0.0	N/A	DWS Length (in)	N/A
N/A	Landing X Slope (%)	0.0	N/A	DWS Full Width?	N/A
N/A	Landing Curb? (Y/N)	N/A	N/A	DWS Offset LT (in)	N/A
N/A	Shared Landing?	N/A	N/A	DWS Offset RT (in)	N/A
N/A	Gutter Ponding?	0.0	N/A	Gutter Slope (%)	N/A
N/A	Gutter Lip Ht (in)	0.0	N/A	Gutter X Slope (%)	N/A
N/A	Painted X Walk1?	No		Road Slope (%)	1.2
	X Walk 1 Direction	To W		Road X Slope (%)	2.6
	X Walk 1 Width (in)	N/A		Clear Space?	N/A

X Walk 1 Slope (%)	1.2	N/A	Clear Space to XWalk (in)	N/A
	X Walk 1 X Slope (%)	2.6	N/A	Storm Grate/Utility Hazard?	N/A
N/A	Ramp inside XWalk1?	N/A		Storm Grate/Utility Type	
N/A	Any Obstructions?	N/A			N/A
	Obstruction Type		Yes	Surface Condition? (G/P)	Good
			N/A	Curb Slope (%)	0.2

Possible Solutions:

Remove & Replace Entire Ramp.

R304.5.3
