Access Compliance Report

Public Rights-of-Way

(Curb Ramps)

Intersection ID: 17177	Main Street: CASTLETON_RD	Cross Street: LOMAX_AV	Location:	E
ADA ID: 51AACE670D0C	Ramp Type: Perp	Initial Pass/Fail: Fail	Overall Compliance: No	Severity Score: 37.5

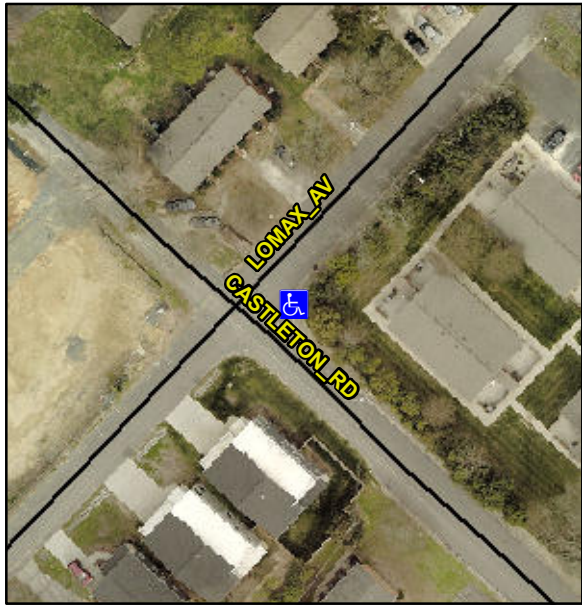
Possible Solutions:		Compliance	Description	Data	Compliance	Description	Data
	Remove & Replace Entire Ramp.		N/A	Ramp Length (in)	48.0	No	Ramp Slope (%)	12.3
			Yes	Ramp Width (in)	48.0	No	Ramp XSlope (%)	5.3
			N/A	Flare Type LT	N/A	N/A	Flare Type RT	N/A
			N/A	Flare Slope LT (%)	N/A	N/A	Flare Slope RT (%)	N/A
			N/A	Flare Traversable LT?	N/A	N/A	Flare Traversable RT?	N/A
			N/A	Landing Length (in)	N/A	N/A	DWS Provided?	N/A
			N/A	Landing Width (in)	N/A	N/A	DWS Contrast?	N/A
			N/A	Landing Slope (%)	N/A	N/A	DWS Length (in)	N/A
			N/A	Landing X Slope (%)	N/A	N/A	DWS Full Width?	N/A
Surveyor Notes:		N/A	N/A	Landing Curb? (Y/N)	N/A	N/A	DWS Offset (in)	N/A
PROW/ADA:		Not Found, R304.2.2, R304.5.3	N/A	Shared Landing?	N/A	N/A	Gutter Slope (%)	N/A
			N/A	Gutter Ponding?	N/A	N/A	Gutter X Slope (%)	N/A
			N/A	Gutter Lip Ht (in)	N/A	N/A	Painted X Walk2?	N/A

N/A	Painted X Walk1?	No	N/A	X Walk 2 Direction	N/A
				X Walk 1 Direction	To W		X Walk 2 Width (in)	N/A
			N/A	X Walk 1 Width (in)	N/A	N/A	X Walk 2 Slope (%)	N/A
				X Walk 1 Slope (%)	0.9		X Walk 2 X Slope (%)	N/A
				X Walk 1 X Slope (%)	2.3		Ramp inside XWalk2?	N/A
			N/A	Ramp inside XWalk1?	N/A	N/A	Clear Space?	N/A
				Road Slope (%)	N/A	N/A	Clear Space to XWalk (in)	N/A
				Road X Slope (%)	N/A	N/A	Storm Grate/Utility Hazard?	N/A
			N/A	Any Obstructions?	N/A	N/A	Storm Grate/Utility Type	
				Obstruction Type				
					N/A			N/A
						Yes	Surface Condition? (G/P)	Good
Street 1 Name		LOMAX AV						
Stop Condition-Street 2		None						
Street 2 Name		N/A						
Stop Condition-Street 1		N/A						
Total Cost:		\$ 1850.00
