Access Compliance Report Public Rights-of-Way (Curb Ramps)

Intersection ID: N/A Main Street: YORK CENTER **Cross Street: N/A** Location: ADA ID: 51BB7035C8D3 Ramp Type: PerpDiag Initial Pass/Fail: Fail **Overall Compliance: No Severity Score:** 60

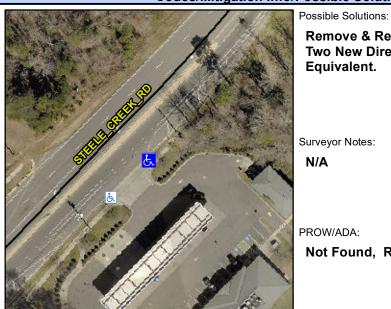
Compliance Description		Data		Compliance Description	
N/A	Ramp Length (in)	61.0	Yes	Ramp Slope (%)	7.1
No	Ramp Width (in)	25.0	No	Ramp XSlope (%)	9.4
N/A	Flare Type LT	N/A	N/A	Flare Type RT	N/A
N/A	Flare Slope LT (%)	N/A	N/A	Flare Slope RT (%)	N/A
N/A	Flare Traversable LT?	N/A	N/A	Flare Traversable RT?	N/A
N/A	Landing Length (in)	N/A	N/A	DWS Provided?	N/A
N/A	Landing Width (in)	N/A	N/A	DWS Contrast?	N/A
N/A	Landing Slope (%)	N/A	N/A	DWS Length (in)	N/A
N/A	Landing X Slope (%)	N/A	N/A	DWS Full Width?	N/A
N/A	Landing Curb? (Y/N)	N/A	N/A	DWS Offset (in)	N/A
N/A	Shared Landing?	N/A			
N/A	Gutter Ponding?	N/A	N/A	Gutter Slope (%)	N/A
N/A	Gutter Lip Ht (in)	N/A	N/A	Gutter X Slope (%)	N/A
N/A	Painted X Walk1?	No	N/A	Painted X Walk2?	No
	X Walk 1 Direction	To W		X Walk 2 Direction	To S
N/A	X Walk 1 Width (in)	N/A	N/A	X Walk 2 Width (in)	N/A
	X Walk 1 Slope (%)	7.2		X Walk 2 Slope (%)	1.8
	X Walk 1 X Slope (%)	0.8		X Walk 2 X Slope (%)	7.8

N/A	Ramp inside XWalk1?	N/A	N/A	Ramp inside XWalk2?	N/A
	Road Slope (%)	5.6	N/A	Clear Space?	N/A
	Road X Slope (%)	3.7	N/A	Clear Space to XWalk (in)	N/A
N/A	Any Obstructions?	N/A	N/A	Storm Grate/Utility Hazard?	N/A
	Obstruction Type		l	Storm Grate/Utility Type	
		N/A			N/A
			Yes	Surface Condition? (G/P)	Good

Remove & Replace Curb Ramp With Two New Directional Ramps or Equivalent.

Total Cost: 3200.00
