# Access Compliance Report

## Public Rights-of-Way

### (Curb Ramps)

Intersection ID: N/A	Main Street: NEW_FASHION_WY	Cross Street: N/A	Location: E
ADA ID: 51BD0BB48C46	Ramp Type: Perp	Initial Pass/Fail: Fail	Overall Compliance: No
Severity Score: 12.5			
Codes/Mitigation Info/Possible Solution		Field Measurements/Component Compliance

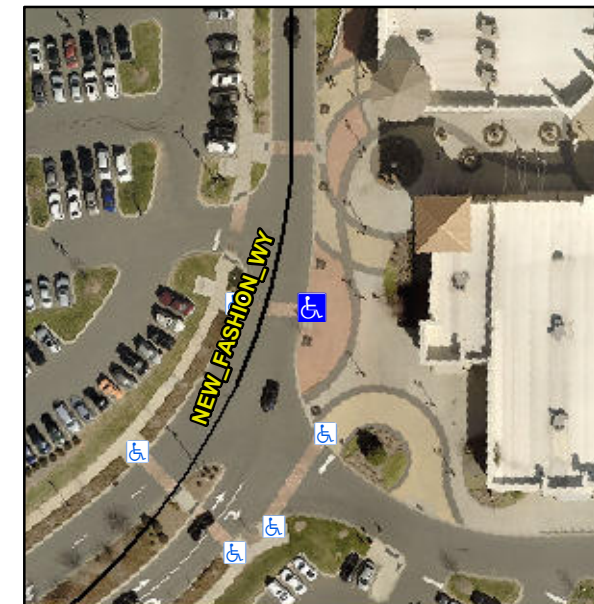
**R304.2.2**

Compliance	Description	Data	Compliance	Description	Data
N/A	Ramp Length (in)	59.0	No	Ramp Slope (%)	9.0
Yes	Ramp Width (in)	48.0	Yes	Ramp XSlope (%)	1.2
N/A	Flare Type LT	N/A	N/A	Flare Type RT	N/A
N/A	Flare Slope LT (%)	N/A	N/A	Flare Slope RT (%)	N/A
N/A	Flare Traversable LT?	N/A	N/A	Flare Traversable RT?	N/A
N/A	Landing Length (in)	N/A	N/A	DWS Provided?	N/A
N/A	Landing Width (in)	N/A	N/A	DWS Contrast?	N/A
N/A	Landing Slope (%)	N/A	N/A	DWS Length (in)	N/A
N/A	Landing X Slope (%)	N/A	N/A	DWS Full Width?	N/A
N/A	Landing Curb? (Y/N)	N/A	N/A	DWS Offset (in)	N/A
N/A	Shared Landing?	N/A			
N/A	Gutter Ponding?	N/A	N/A	Gutter Slope (%)	N/A
N/A	Gutter Lip Ht (in)	N/A	N/A	Gutter X Slope (%)	N/A
N/A	Painted X Walk1?	Yes	N/A	Painted X Walk2?	N/A
	X Walk 1 Direction	To NW		X Walk 2 Direction	N/A
N/A	X Walk 1 Width (in)	80.5	N/A	X Walk 2 Width (in)	N/A
	X Walk 1 Slope (%)	0.8		X Walk 2 Slope (%)	N/A
	X Walk 1 X Slope (%)	1.4		X Walk 2 X Slope (%)	N/A

**Remove & Replace Entire Ramp.**

**\$ 1850.00**

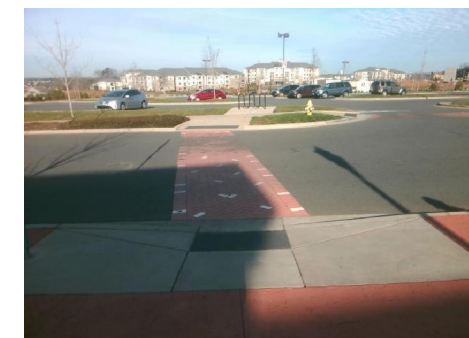
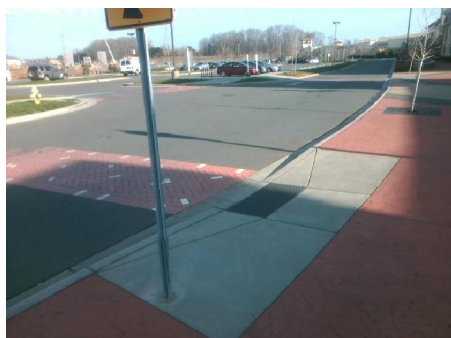
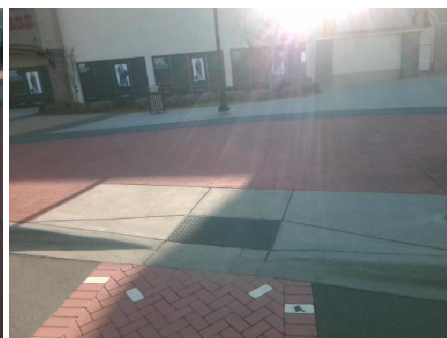
N/A	Ramp inside XWalk1?	Yes	N/A	Ramp inside XWalk2?	N/A
	Road Slope (%)	N/A	N/A	Clear Space?	N/A
	Road X Slope (%)	N/A	N/A	Clear Space to XWalk (in)	N/A
N/A	Any Obstructions?	N/A	N/A	Storm Grate/Utility Hazard?	N/A
	Obstruction Type			Storm Grate/Utility Type	
		N/A			N/A
		Yes		Surface Condition? (G/P)	Good
