Access Compliance Report

Public Rights-of-Way

(Curb Ramps)

Intersection ID: 10025796	Main Street: EDGEHILL_RD_NORTH	Cross Street: N/A	Location: SE
ADA ID: 51C359E018C3	Ramp Type: BlendTrans1	Initial Pass/Fail: Fail	Overall Compliance: No
Codes/Mitigation Info/Possible Solution		Field Measurements/Component Compliance	
Severity Score: 25

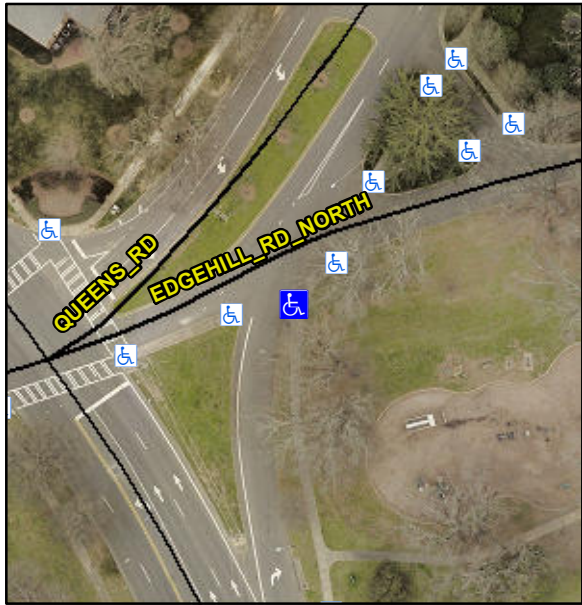
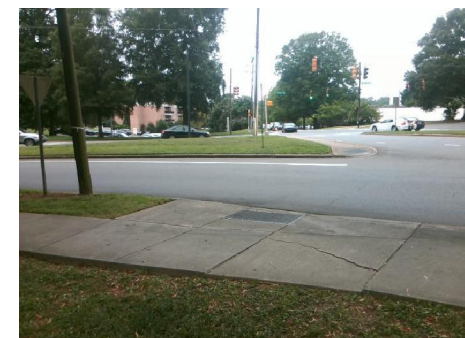
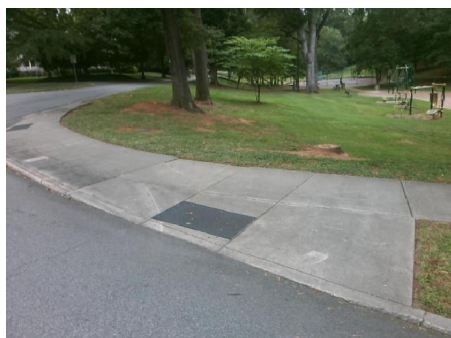
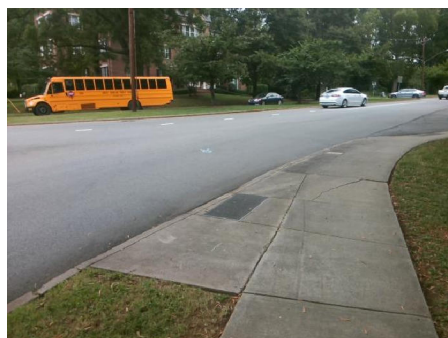
Compliance	Description	Data	Compliance	Description	Data
N/A	Ramp Length (in)	43.0	Yes	BlendTrans Slope (%)	0.1
Yes	Ramp Width (in)	48.0	No	BlendTrans XSlope (%)	7.2
N/A	Flare Type LT	N/A	N/A	Flare Type RT	N/A
N/A	Flare Slope LT (%)	N/A	N/A	Flare Slope RT (%)	N/A
N/A	Flare Traversable LT?	N/A	N/A	Flare Traversable RT?	N/A
N/A	Landing Length (in)	N/A	N/A	DWS Provided?	N/A
N/A	Landing Width (in)	N/A	N/A	DWS Contrast?	N/A
N/A	Landing Slope (%)	N/A	N/A	DWS Length (in)	N/A
N/A	Landing X Slope (%)	N/A	N/A	DWS Full Width?	N/A
N/A	Landing Curb? (Y/N)	N/A	N/A	DWS Offset (in)	N/A
N/A	Shared Landing?	N/A			
N/A	Gutter Ponding?	N/A	N/A	Gutter Slope (%)	N/A
N/A	Gutter Lip Ht (in)	N/A	N/A	Gutter X Slope (%)	N/A
N/A	Painted X Walk1?	No	N/A	Painted X Walk2?	N/A
	X Walk 1 Direction	To SW		X Walk 2 Direction	N/A
	X Walk 1 Width (in)	N/A		X Walk 2 Width (in)	N/A
	X Walk 1 Slope (%)	3.3		X Walk 2 Slope (%)	N/A
	X Walk 1 X Slope (%)	6.2		X Walk 2 X Slope (%)	N/A

N/A	Ramp inside XWalk1?	N/A	N/A	Ramp inside XWalk2?	N/A
	Road Slope (%)	6.2		Clear Space?	N/A
	Road X Slope (%)	3.3	N/A	Clear Space to XWalk (in)	N/A
N/A	Any Obstructions?	N/A	N/A	Storm Grate/Utility Hazard?	N/A
	Obstruction Type			Storm Grate/Utility Type	
		N/A			N/A
			Yes	Surface Condition? (G/P)	Good
			N/A	Curb Slope (%)	4.9

Remove & Replace Curb Ramp With Two New Directional Ramps or Equivalent.

R304.5.3
