Access Compliance Report

Public Rights-of-Way

(Curb Ramps)

Intersection ID: 20994	Main Street: BLUESHOT_CT	Cross Street: BRICKER_DR	Location: W
ADA ID: 51C9322032DB	Ramp Type: PerpDiag	Initial Pass/Fail: Fail	Overall Compliance: No
		Severity Score: 12.5

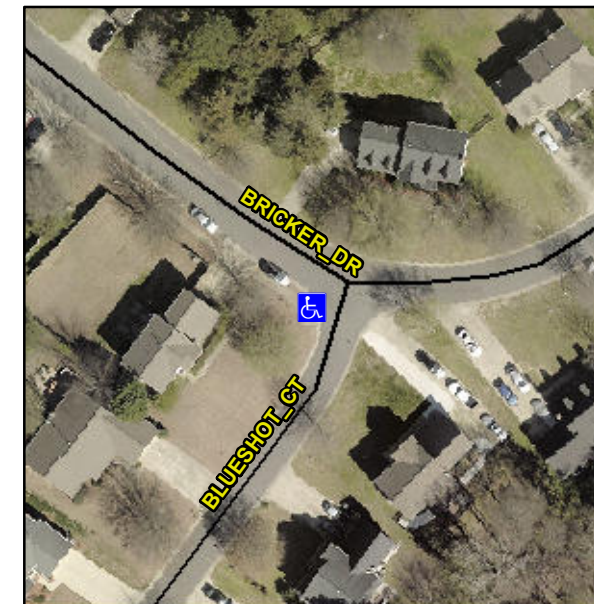
Not Found, R304.5.3

Compliance	Description	Data	Compliance	Description	Data
N/A	Ramp Length (in)	48.0	Yes	Ramp Slope (%)	5.7
Yes	Ramp Width (in)	48.0	No	Ramp XSlope (%)	5.9
N/A	Flare Type LT	N/A	N/A	Flare Type RT	N/A
N/A	Flare Slope LT (%)	N/A	N/A	Flare Slope RT (%)	N/A
N/A	Flare Traversable LT?	N/A	N/A	Flare Traversable RT?	N/A
N/A	Landing Length (in)	N/A	N/A	DWS Provided?	N/A
N/A	Landing Width (in)	N/A	N/A	DWS Contrast?	N/A
N/A	Landing Slope (%)	N/A	N/A	DWS Length (in)	N/A
N/A	Landing X Slope (%)	N/A	N/A	DWS Full Width?	N/A
N/A	Landing Curb? (Y/N)	N/A	N/A	DWS Offset (in)	N/A
N/A	Shared Landing?	N/A			
N/A	Gutter Ponding?	N/A	N/A	Gutter Slope (%)	N/A
N/A	Gutter Lip Ht (in)	N/A	N/A	Gutter X Slope (%)	N/A
N/A	Painted X Walk1?	No	N/A	Painted X Walk2?	No
	X Walk 1 Direction	To SE		X Walk 2 Direction	To NE
N/A	X Walk 1 Width (in)	N/A	N/A	X Walk 2 Width (in)	N/A
	X Walk 1 Slope (%)	0.5		X Walk 2 Slope (%)	5.0
	X Walk 1 X Slope (%)	4.1		X Walk 2 X Slope (%)	0.1

N/A	Ramp inside XWalk1?	N/A	N/A	Ramp inside XWalk2?	N/A
	Road Slope (%)	3.3	N/A	Clear Space?	N/A
	Road X Slope (%)	2.0	N/A	Clear Space to XWalk (in)	N/A
N/A	Any Obstructions?	N/A	N/A	Storm Grate/Utility Hazard?	N/A
	Obstruction Type			Storm Grate/Utility Type	
		N/A			N/A
		Yes		Surface Condition? (G/P)	Good

Remove & Replace Curb Ramp With Two New Directional Ramps or Equivalent.
