Access Compliance Report Public Rights-of-Way (Curb Ramps)

Intersection ID: 4834 Main Street: EDGEVALE_DR Cross Street: FELDBANK_DR Location: SE

ADA ID: 51C94F9EC53C Ramp Type: BlendTrans2 Initial Pass/Fail: Fail Overall Compliance: No Severity Score: 47.5

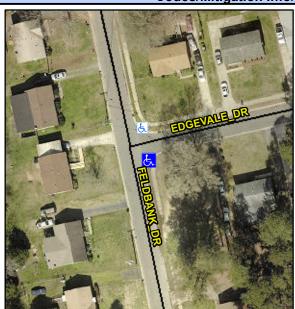
NO LT SW

Not Found, R304.5.1, R304.5.3

Field Measurements/Component Compnance						
	Compl	iance Description	Data	Compliance Description		Data
	N/A	Ramp Length (in)	106.0	Yes	BlendTrans Slope (%)	3.8
	No	Ramp Width (in)	29.0	No	BlendTrans XSlope (%)	5.4
	N/A	Flare Type LT	N/A	N/A	Flare Type RT	N/A
	N/A	Flare Slope LT (%)	N/A	N/A	Flare Slope RT (%)	N/A
	N/A	Flare Traversable LT?	N/A	N/A	Flare Traversable RT?	N/A
	N/A	Landing Length (in)	N/A	N/A	DWS Provided?	N/A
	N/A	Landing Width (in)	N/A	N/A	DWS Contrast?	N/A
	N/A	Landing Slope (%)	N/A	N/A	DWS Length (in)	N/A
	N/A	Landing X Slope (%)	N/A	N/A	DWS Full Width?	N/A
	N/A	Landing Curb? (Y/N)	N/A	N/A	DWS Offset (in)	N/A
	N/A	Shared Landing?	N/A			
	N/A	Gutter Ponding?	N/A	N/A	Gutter Slope (%)	N/A
	N/A	Gutter Lip Ht (in)	N/A	N/A	Gutter X Slope (%)	N/A
	N/A	Painted X Walk1?	No	N/A	Painted X Walk2?	N/A
		X Walk 1 Direction	To N		X Walk 2 Direction	N/A
		X Walk 1 Width (in)	N/A		X Walk 2 Width (in)	N/A
		X Walk 1 Slope (%)	1.5		X Walk 2 Slope (%)	N/A

X Walk 1 X Slope (%)	1.9		X Walk 2 X Slope (%)	N/A
	N/A	Ramp inside XWalk1?	N/A	N/A	Ramp inside XWalk2?	N/A
		Road Slope (%)	1.9		Clear Space?	N/A
		Road X Slope (%)	1.5	N/A	Clear Space to XWalk (in)	N/A
	N/A	Any Obstructions?	N/A	N/A	Storm Grate/Utility Hazard?	N/A
		Obstruction Type			Storm Grate/Utility Type	
			N/A			N/A
				Yes	Surface Condition? (G/P)	Good
THE REAL PROPERTY.				No	Curb Slope (%)	12.6

Remove & Replace Curb Ramp With Two New Directional Ramps or Equivalent.
