## Access Compliance Report Public Rights-of-Way (Curb Ramps)

Intersection ID: 26468Main Street: BEVINGTON\_PLCross Street: REA\_RDLocation:NEADA ID: 51CDEB1658F1Ramp Type: PerpDiagInitial Pass/Fail: FailOverall Compliance: NoSeverity Score:25

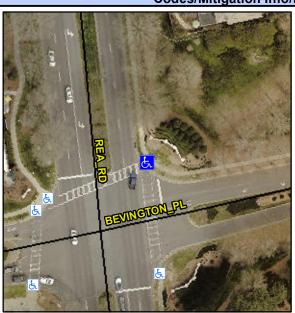
Not Found, R304.5.3

Field Measurements/Component Compliance					
Compliance Description		Data	Compliance Description		Data
N/A	Ramp Length (in)	107.0	Yes	Ramp Slope (%)	5.2
Yes	Ramp Width (in)	48.0	No	Ramp XSlope (%)	8.4
N/A	Flare Type LT	N/A	N/A	Flare Type RT	N/A
N/A	Flare Slope LT (%)	N/A	N/A	Flare Slope RT (%)	N/A
N/A	Flare Traversable LT?	N/A	N/A	Flare Traversable RT?	N/A
N/A	Landing Length (in)	N/A	N/A	DWS Provided?	N/A
N/A	Landing Width (in)	N/A	N/A	DWS Contrast?	N/A
N/A	Landing Slope (%)	N/A	N/A	DWS Length (in)	N/A
N/A	Landing X Slope (%)	N/A	N/A	DWS Full Width?	N/A
N/A	Landing Curb? (Y/N)	N/A	N/A	DWS Offset (in)	N/A
N/A	Shared Landing?	N/A			
N/A	Gutter Ponding?	N/A	N/A	Gutter Slope (%)	N/A
N/A	Gutter Lip Ht (in)	N/A	N/A	Gutter X Slope (%)	N/A
N/A	Painted X Walk1?	Yes	N/A	Painted X Walk2?	Yes
	X Walk 1 Direction	To SW		X Walk 2 Direction	To S
N/A	X Walk 1 Width (in)	124.0	N/A	X Walk 2 Width (in)	127.0
	X Walk 1 Slope (%)	0.4		X Walk 2 Slope (%)	2.1

X Walk 1 X Slope (%)	3.0		X Walk 2 X Slope (%)	3.9
N/A	Ramp inside XWalk1?	Yes	N/A	Ramp inside XWalk2?	Yes
	Road Slope (%)	4.5	N/A	Clear Space?	N/A
	Road X Slope (%)	0.9	N/A	Clear Space to XWalk (in)	N/A
N/A	Any Obstructions?	N/A	N/A	Storm Grate/Utility Hazard?	N/A
	Obstruction Type			Storm Grate/Utility Type	
		N/A			N/A
			Yes	Surface Condition? (G/P)	Good
A TAR STORM TO	100	'	-	, ,

Remove & Replace Curb Ramp With
Two New Directional Ramps or
Equivalent.

Total Cost: \$ 3200.00
