Access Compliance Report

Public Rights-of-Way

(Curb Ramps)

Intersection ID: 10024053	Main Street: CORONATION_BV	Cross Street: N/A	Location: S
ADA ID: 51DCE26E1A91	Ramp Type: PerpDiag	Initial Pass/Fail: Fail	Overall Compliance: No
Codes/Mitigation Info/Possible Solution		Field Measurements/Component Compliance	
		Severity Score: 50

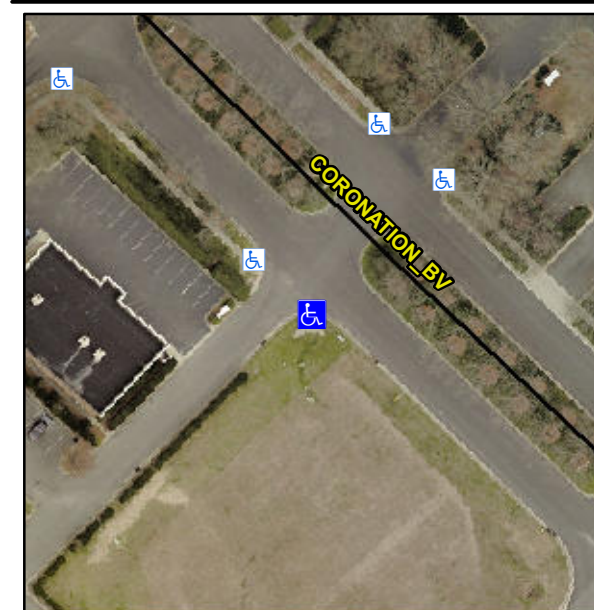
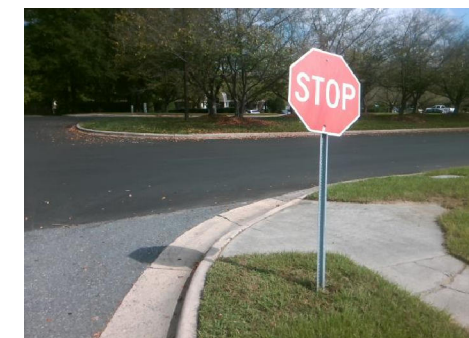
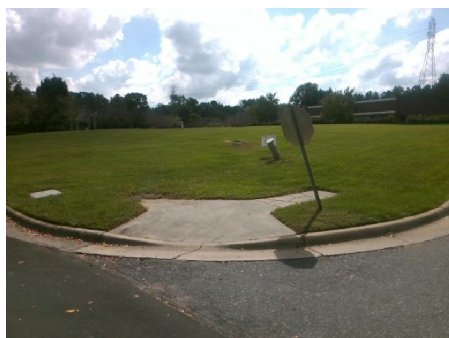
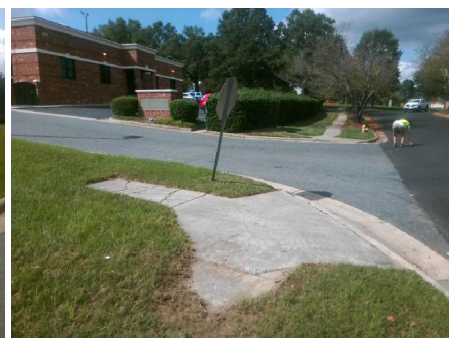
Not Found, R304.2.2, R304.5.3

Compliance	Description	Data	Compliance	Description	Data
N/A	Ramp Length (in)	98.0	No	Ramp Slope (%)	12.7
Yes	Ramp Width (in)	48.0	No	Ramp XSlope (%)	9.3
N/A	Flare Type LT	N/A	N/A	Flare Type RT	N/A
N/A	Flare Slope LT (%)	N/A	N/A	Flare Slope RT (%)	N/A
N/A	Flare Traversable LT?	N/A	N/A	Flare Traversable RT?	N/A
N/A	Landing Length (in)	N/A	N/A	DWS Provided?	N/A
N/A	Landing Width (in)	N/A	N/A	DWS Contrast?	N/A
N/A	Landing Slope (%)	N/A	N/A	DWS Length (in)	N/A
N/A	Landing X Slope (%)	N/A	N/A	DWS Full Width?	N/A
N/A	Landing Curb? (Y/N)	N/A	N/A	DWS Offset (in)	N/A
N/A	Shared Landing?	N/A			
N/A	Gutter Ponding?	N/A	N/A	Gutter Slope (%)	N/A
N/A	Gutter Lip Ht (in)	N/A	N/A	Gutter X Slope (%)	N/A
N/A	Painted X Walk1?	No	N/A	Painted X Walk2?	No
	X Walk 1 Direction	To NE		X Walk 2 Direction	To NW
N/A	X Walk 1 Width (in)	N/A	N/A	X Walk 2 Width (in)	N/A
	X Walk 1 Slope (%)	1.2		X Walk 2 Slope (%)	5.3
	X Walk 1 X Slope (%)	1.1		X Walk 2 X Slope (%)	6.1

N/A	Ramp inside XWalk1?	N/A	N/A	Ramp inside XWalk2?	N/A
	Road Slope (%)	10.2	N/A	Clear Space?	N/A
	Road X Slope (%)	6.5	N/A	Clear Space to XWalk (in)	N/A
N/A	Any Obstructions?	N/A	N/A	Storm Grate/Utility Hazard?	N/A
	Obstruction Type			Storm Grate/Utility Type	
		N/A			N/A
			Yes	Surface Condition? (G/P)	Good

Remove & Replace Curb Ramp With Two New Directional Ramps or Equivalent.
