Access Compliance Report

Public Rights-of-Way (Curb Ramps)

| Intersection ID: 10029698 | Main Street: KINGSTON_FOREST_DR | Cross Street: N/A | Location: SW |
| ADA ID: 51ED4B341CC1 | Ramp Type: Perp | Initial Pass/Fail: Fail | Overall Compliance: No |

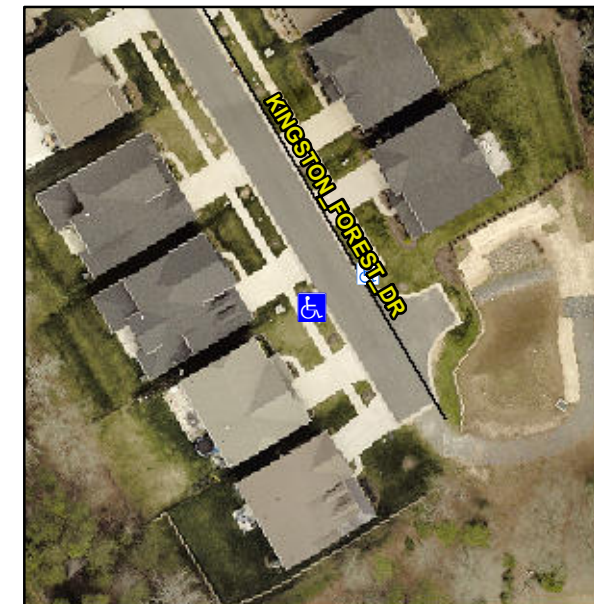
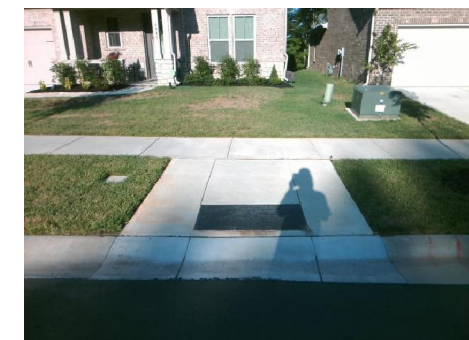
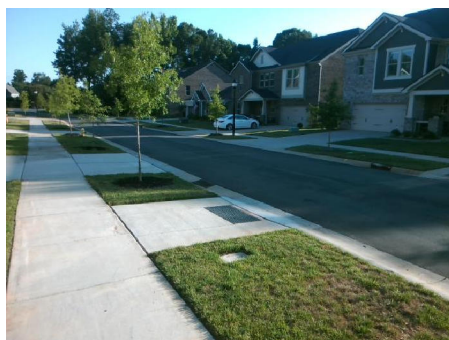
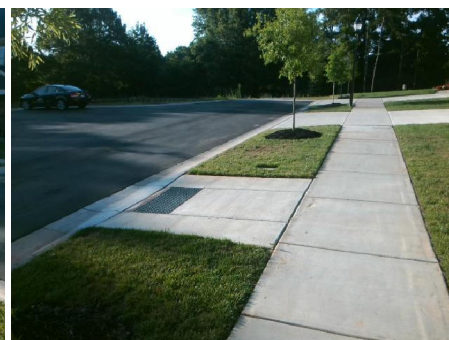
| Severity Score: 8.75 | | | |

Not Found, R304.5.1

| Compliance | Description | Data | Compliance | Description | Data |
|---|---|---|---|---|---|
| No | Ramp Width (in) | 46.5 | Yes | Ramp XSlope (%) | 0.3 |

Remove & Replace Entire Ramp.

Total Cost: \$ 1850.00
