Access Compliance Report

Public Rights-of-Way

(Curb Ramps)

| Intersection ID: 23387 | Main Street: OBERBECK_LN | Cross Street: SHARON_RD_WEST | Location: SE |

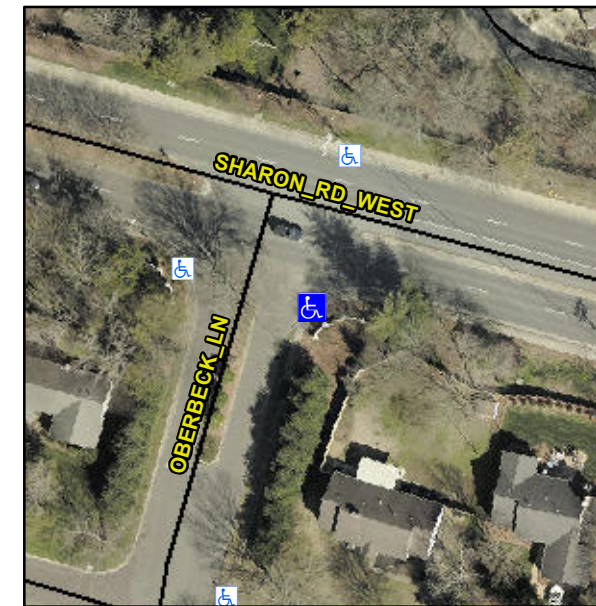
| ADA ID: 51FA1156DE08 | Ramp Type: PerpDiag | Initial Pass/Fail: Fail | Overall Compliance: No |

Not Found, R304.2.2, R304.5.3

| Compliance | Description | Data | Compliance | Description | Data |
|---|---|---|---|---|---|
| N/A | Ramp Length (in) | 55.0 | No | Ramp Slope (%) | 9.0 |
| Yes | Ramp Width (in) | 48.0 | No | Ramp XSlope (%) | 5.1 |

Remove & Replace Curb Ramp With Two New Directional Ramps or Equivalent.
