Access Compliance Report

Public Rights-of-Way

(Curb Ramps)

Intersection ID: 44919	Main Street: PALUSTRIS_CT	Cross Street: MINTVALE_DR	Location: SE
ADA ID: 51FB2C51E117	Ramp Type: PerpDiag	Initial Pass/Fail: Fail	Overall Compliance: No
Severity Score: 33.75			
Codes/Mitigation Info/Possible Solution		Field Measurements/Component Compliance

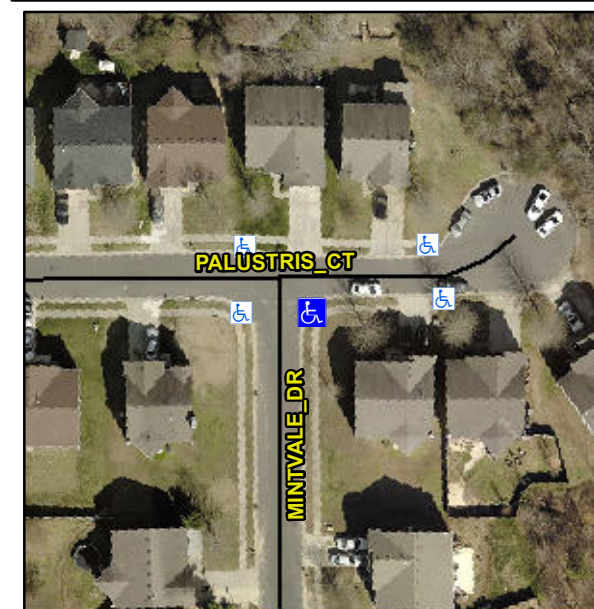
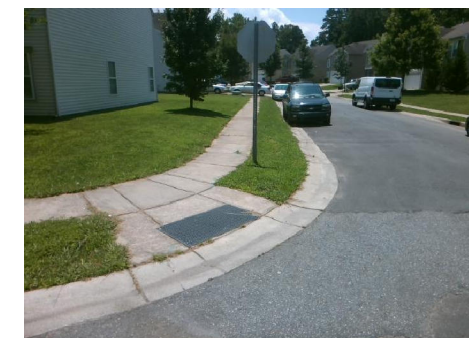
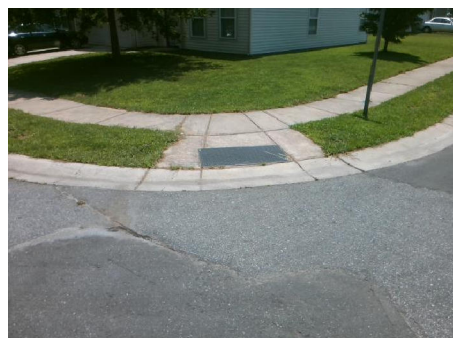
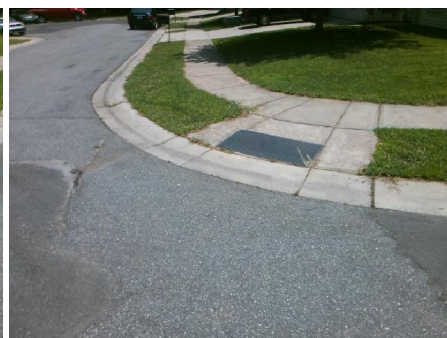
Not Found, R304.5.1, R304.2.2

Compliance	Description	Data	Compliance	Description	Data
N/A	Ramp Length (in)	47.5	No	Ramp Slope (%)	13.0
No	Ramp Width (in)	38.5	Yes	Ramp XSlope (%)	1.0
N/A	Flare Type LT	N/A	N/A	Flare Type RT	N/A
N/A	Flare Slope LT (%)	N/A	N/A	Flare Slope RT (%)	N/A
N/A	Flare Traversable LT?	N/A	N/A	Flare Traversable RT?	N/A
N/A	Landing Length (in)	N/A	N/A	DWS Provided?	N/A
N/A	Landing Width (in)	N/A	N/A	DWS Contrast?	N/A
N/A	Landing Slope (%)	N/A	N/A	DWS Length (in)	N/A
N/A	Landing X Slope (%)	N/A	N/A	DWS Full Width?	N/A
N/A	Landing Curb? (Y/N)	N/A	N/A	DWS Offset (in)	N/A
N/A	Shared Landing?	N/A			
N/A	Gutter Ponding?	N/A	N/A	Gutter Slope (%)	N/A
N/A	Gutter Lip Ht (in)	N/A	N/A	Gutter X Slope (%)	N/A
N/A	Painted X Walk1?	No	N/A	Painted X Walk2?	No
	X Walk 1 Direction	To N		X Walk 2 Direction	To W
N/A	X Walk 1 Width (in)	N/A	N/A	X Walk 2 Width (in)	N/A
	X Walk 1 Slope (%)	3.0		X Walk 2 Slope (%)	4.5
	X Walk 1 X Slope (%)	4.4		X Walk 2 X Slope (%)	2.6

N/A	Ramp inside XWalk1?	N/A	N/A	Ramp inside XWalk2?	N/A
	Road Slope (%)	0.3	N/A	Clear Space?	N/A
	Road X Slope (%)	5.2	N/A	Clear Space to XWalk (in)	N/A
N/A	Any Obstructions?	N/A	N/A	Storm Grate/Utility Hazard?	N/A
	Obstruction Type			Storm Grate/Utility Type	
		N/A			N/A
		Yes		Surface Condition? (G/P)	Good

Remove & Replace Curb Ramp With Two New Directional Ramps or Equivalent.
