# Access Compliance Report

## Public Rights-of-Way

### (Curb Ramps)

| Intersection ID: 27760 | Main Street: BALLANTYNE_COUNTRY_CLUB_DR | Cross Street: BALLANTYNE_CROSSING_AV | Location: SW |

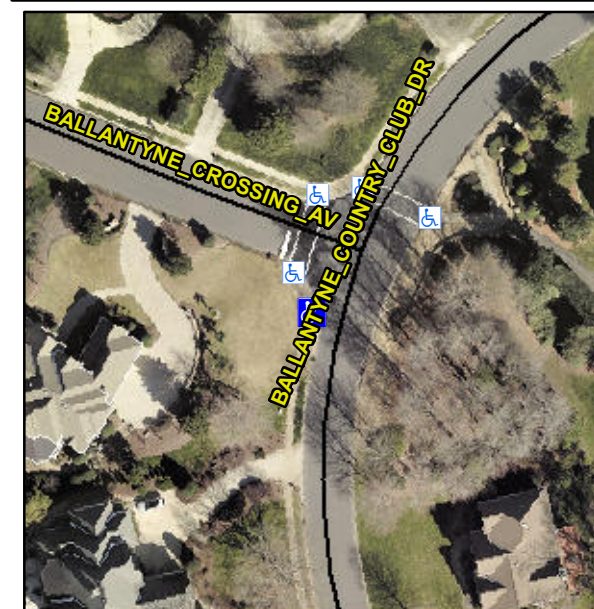
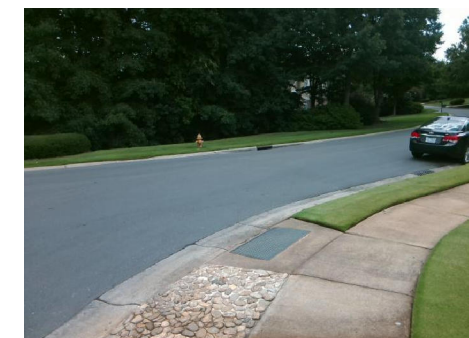
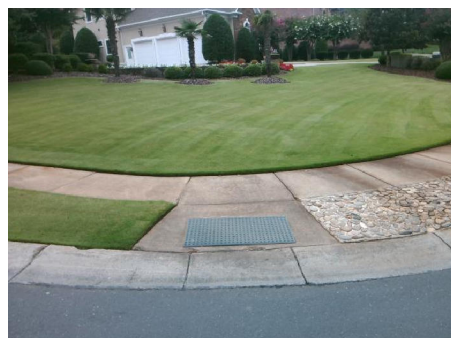
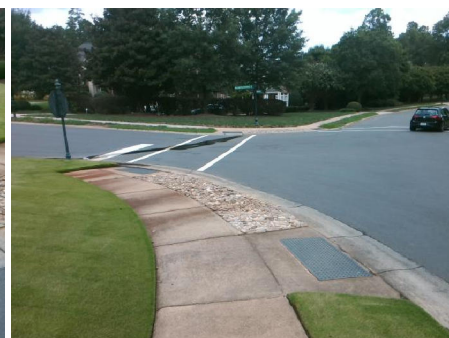
**R304.5.1, R304.2.2, R304.5.3**

| Compliance | Description | Data | Compliance | Description | Data |
|---|---|---|---|---|---|
| N/A | Ramp Length (in) | 46.0 | No | Ramp Slope (%) | 9.1 |
| No | Ramp Width (in) | 41.0 | No | Ramp XSlope (%) | 5.6 |

**Remove & Replace Entire Ramp.**
