# Access Compliance Report

## Public Rights-of-Way

### (Curb Ramps)

Intersection ID: 27280	Main Street: BACK_RIDGE_RD	Cross Street: ELMSTONE_DR	Location: NE
ADA ID: 521211F1C8F4	Ramp Type: PerpDiag	Initial Pass/Fail: Fail	Overall Compliance: No
Severity Score: 50			
Codes/Mitigation Info/Possible Solution		Field Measurements/Component Compliance

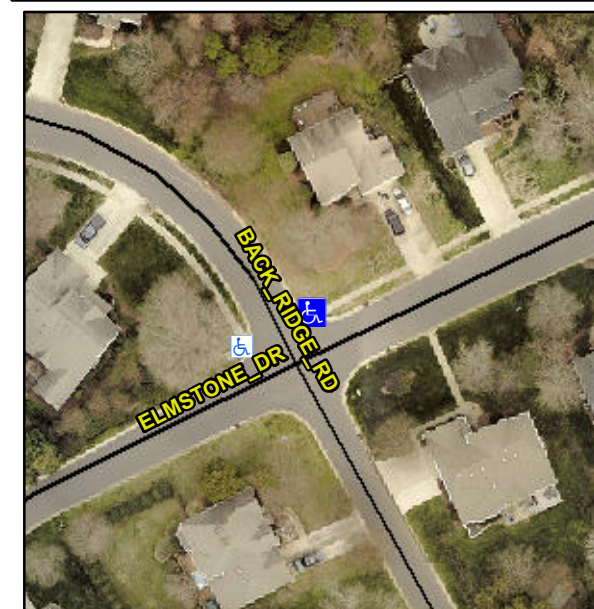
**Not Found, R304.2.2, R304.5.3**

Compliance	Description	Data	Compliance	Description	Data
N/A	Ramp Length (in)	35.0	No	Ramp Slope (%)	12.9
Yes	Ramp Width (in)	48.0	No	Ramp XSlope (%)	8.2
N/A	Flare Type LT	N/A	N/A	Flare Type RT	N/A
N/A	Flare Slope LT (%)	N/A	N/A	Flare Slope RT (%)	N/A
N/A	Flare Traversable LT?	N/A	N/A	Flare Traversable RT?	N/A
N/A	Landing Length (in)	N/A	N/A	DWS Provided?	N/A
N/A	Landing Width (in)	N/A	N/A	DWS Contrast?	N/A
N/A	Landing Slope (%)	N/A	N/A	DWS Length (in)	N/A
N/A	Landing X Slope (%)	N/A	N/A	DWS Full Width?	N/A
N/A	Landing Curb? (Y/N)	N/A	N/A	DWS Offset (in)	N/A
N/A	Shared Landing?	N/A			
N/A	Gutter Ponding?	N/A	N/A	Gutter Slope (%)	N/A
N/A	Gutter Lip Ht (in)	N/A	N/A	Gutter X Slope (%)	N/A
N/A	Painted X Walk1?	No	N/A	Painted X Walk2?	No
	X Walk 1 Direction	To W		X Walk 2 Direction	To SE
N/A	X Walk 1 Width (in)	N/A	N/A	X Walk 2 Width (in)	N/A
	X Walk 1 Slope (%)	3.7		X Walk 2 Slope (%)	5.9
	X Walk 1 X Slope (%)	3.7		X Walk 2 X Slope (%)	7.5

N/A	Ramp inside XWalk1?	N/A	N/A	Ramp inside XWalk2?	N/A
	Road Slope (%)	8.0	N/A	Clear Space?	N/A
	Road X Slope (%)	1.1	N/A	Clear Space to XWalk (in)	N/A
N/A	Any Obstructions?	N/A	N/A	Storm Grate/Utility Hazard?	N/A
	Obstruction Type			Storm Grate/Utility Type	
		N/A			N/A
		Yes		Surface Condition? (G/P)	Good

**Remove & Replace Curb Ramp With Two New Directional Ramps or Equivalent.**

Total Cost: \$ 3200.00
