## **Access Compliance Report Public Rights-of-Way** (Curb Ramps)

Intersection ID: 11727 Main Street: W\_8TH\_ST Cross Street: N\_POPLAR\_ST Location: W ADA ID: 5216547465DF Ramp Type: PerpDiag Initial Pass/Fail: Fail **Overall Compliance: No Severity Score:** 12.5

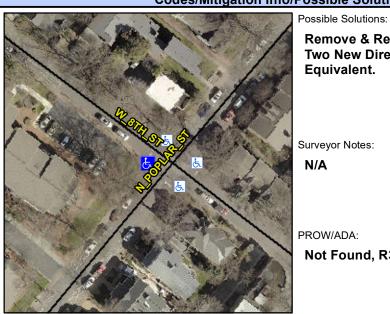
Fleid Measurements/Component Compnance								
Compliance Description		Data	Compliance Description		Data			
	N/A	Ramp Length (in)	44.0	No	Ramp Slope (%)	11.9		
	Yes	Ramp Width (in)	72.0	Yes	Ramp XSlope (%)	1.4		
	N/A	Flare Type LT	N/A	N/A	Flare Type RT	N/A		
	N/A	Flare Slope LT (%)	N/A	N/A	Flare Slope RT (%)	N/A		
	N/A	Flare Traversable LT?	N/A	N/A	Flare Traversable RT?	N/A		
	N/A	Landing Length (in)	N/A	N/A	DWS Provided?	N/A		
	N/A	Landing Width (in)	N/A	N/A	DWS Contrast?	N/A		
	N/A	Landing Slope (%)	N/A	N/A	DWS Length (in)	N/A		
	N/A	Landing X Slope (%)	N/A	N/A	DWS Full Width?	N/A		
	N/A	Landing Curb? (Y/N)	N/A	N/A	DWS Offset (in)	N/A		
	N/A	Shared Landing?	N/A					
	N/A	Gutter Ponding?	N/A	N/A	Gutter Slope (%)	N/A		
	N/A	Gutter Lip Ht (in)	N/A	N/A	Gutter X Slope (%)	N/A		
	N/A	Painted X Walk1?	No	N/A	Painted X Walk2?	No		
		X Walk 1 Direction	To SE		X Walk 2 Direction	To NE		
	N/A	X Walk 1 Width (in)	N/A	N/A	X Walk 2 Width (in)	N/A

X Walk 1 Slope (%)	7.5		X Walk 2 Slope (%)	5.8		
		X Walk 1 X Slope (%)	1.1		X Walk 2 X Slope (%)	2.4		
	N/A	Ramp inside XWalk1?	N/A	N/A	Ramp inside XWalk2?	N/A		
		Road Slope (%)	10.6	N/A	Clear Space?	N/A		
		Road X Slope (%)	7.0	N/A	Clear Space to XWalk (in)	N/A		
	N/A	Any Obstructions?	N/A	N/A	Storm Grate/Utility Hazard?	N/A		
		Obstruction Type			Storm Grate/Utility Type			
			N/A			N/A		
				Yes	Surface Condition? (G/P)	Good

Street 1 Name Stop Condition-Street 2 Street 2 Name Stop Condition-Street 1 Remove & Replace Curb Ramp With **Two New Directional Ramps or** Equivalent.

Total Cost: 3200.00
