# Access Compliance Report

## Public Rights-of-Way

### (Curb Ramps)

Intersection ID: 14397	Main Street: BROOKHILL_RD	Cross Street: REMOUNT_RD	Location: NE
ADA ID: 52207C007868	Ramp Type: PerpDiag	Initial Pass/Fail: Fail	Overall Compliance: No
Severity Score: 37.5			
Codes/Mitigation Info/Possible Solution		Field Measurements/Component Compliance

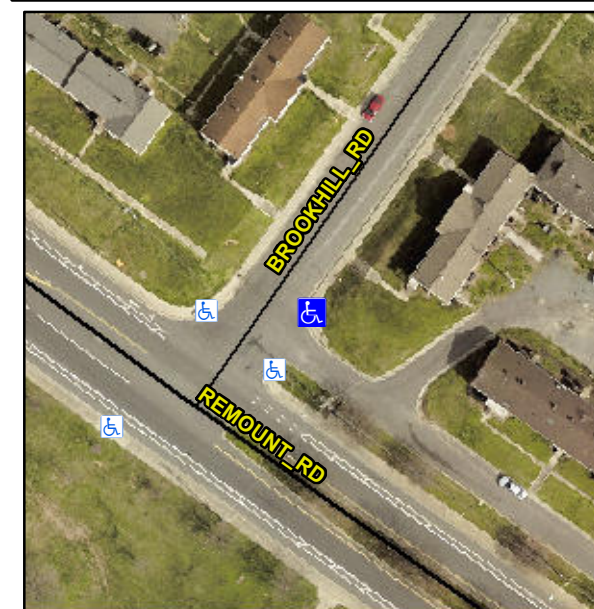
**Not Found, R304.2.2, R304.5.3**

Compliance	Description	Data	Compliance	Description	Data
N/A	Ramp Length (in)	52.0	No	Ramp Slope (%)	11.3
Yes	Ramp Width (in)	48.0	No	Ramp XSlope (%)	8.5
N/A	Flare Type LT	N/A	N/A	Flare Type RT	N/A
N/A	Flare Slope LT (%)	N/A	N/A	Flare Slope RT (%)	N/A
N/A	Flare Traversable LT?	N/A	N/A	Flare Traversable RT?	N/A
N/A	Landing Length (in)	N/A	N/A	DWS Provided?	N/A
N/A	Landing Width (in)	N/A	N/A	DWS Contrast?	N/A
N/A	Landing Slope (%)	N/A	N/A	DWS Length (in)	N/A
N/A	Landing X Slope (%)	N/A	N/A	DWS Full Width?	N/A
N/A	Landing Curb? (Y/N)	N/A	N/A	DWS Offset (in)	N/A
N/A	Shared Landing?	N/A			
N/A	Gutter Ponding?	N/A	N/A	Gutter Slope (%)	N/A
N/A	Gutter Lip Ht (in)	N/A	N/A	Gutter X Slope (%)	N/A
N/A	Painted X Walk1?	No	N/A	Painted X Walk2?	No
	X Walk 1 Direction	To NW		X Walk 2 Direction	To SW
N/A	X Walk 1 Width (in)	N/A	N/A	X Walk 2 Width (in)	N/A
	X Walk 1 Slope (%)	0.9		X Walk 2 Slope (%)	2.8
	X Walk 1 X Slope (%)	4.6		X Walk 2 X Slope (%)	3.1

N/A	Ramp inside XWalk1?	N/A	N/A	Ramp inside XWalk2?	N/A
	Road Slope (%)	5.1	N/A	Clear Space?	N/A
	Road X Slope (%)	0.3	N/A	Clear Space to XWalk (in)	N/A
N/A	Any Obstructions?	N/A	N/A	Storm Grate/Utility Hazard?	N/A
	Obstruction Type			Storm Grate/Utility Type	
		N/A			N/A
			Yes	Surface Condition? (G/P)	Good

**Remove & Replace Curb Ramp With Two New Directional Ramps or Equivalent.**

Total Cost: \$ 3200.00
