Access Compliance Report Public Rights-of-Way (Curb Ramps)

Intersection ID: 30018 Main Street: W_MALLARD_CREEK_CHURCIC_RSDs Street: BERKELEY_PLACE_DR Location: SW

ADA ID: 523C25D0FC72 Ramp Type: Perp Initial Pass/Fail: Fail Overall Compliance: No Severity Score: 33.75

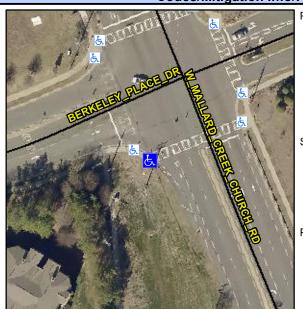
<u>u33/1</u>	an. ran Overan	Compilan	ICC. 14	o ocverity ocore.	33.7			
Field Measurements/Component Compliance								
Com	pliance Description	Data	Comp	oliance Description	Data			
N/A	Ramp Length (in)	61.0	No	Ramp Slope (%)	20.0			
No	Ramp Width (in)	47.0	Yes	Ramp XSlope (%)	1.8			
N/A	Flare Type LT	N/A	N/A	Flare Type RT	N/A			
N/A	Flare Slope LT (%)	N/A	N/A	Flare Slope RT (%)	N/A			
N/A	Flare Traversable LT?	N/A	N/A	Flare Traversable RT?	N/A			
N/A	Landing Length (in)	N/A	N/A	DWS Provided?	N/A			
N/A	Landing Width (in)	N/A	N/A	DWS Contrast?	N/A			
N/A	Landing Slope (%)	N/A	N/A	DWS Length (in)	N/A			
N/A	Landing X Slope (%)	N/A	N/A	DWS Full Width?	N/A			
N/A	Landing Curb? (Y/N)	N/A	N/A	DWS Offset (in)	N/A			
N/A	Shared Landing?	N/A						
N/A	Gutter Ponding?	N/A	N/A	Gutter Slope (%)	N/A			
N/A	Gutter Lip Ht (in)	N/A	N/A	Gutter X Slope (%)	N/A			
N/A	Painted X Walk1?	Yes	N/A	Painted X Walk2?	N/A			
	X Walk 1 Direction	То Е		X Walk 2 Direction	N/A

Possible Solutions:	Con
Remove & Replace Entire Ramp.	N/A
·	No
	N/A
	N/A
	N/A
	N/A
Surveyor Notes:	N/A
N/A	N/A
	N/A
	N/A
	N/A
PROW/ADA:	N/A
R304.5.1, R304.2.2	N/A
	N/A
	N/A
	N/A
