## Access Compliance Report Public Rights-of-Way (Curb Ramps)

Intersection ID: 28367 Main Street: SOUTHAMPTON\_COMMONS\_D@ross Street: TRAVIS\_GULCH\_DR Location: SE

ADA ID: 524348AB1FCB Ramp Type: Perp Initial Pass/Fail: Fail Overall Compliance: No Severity Score: 47.5

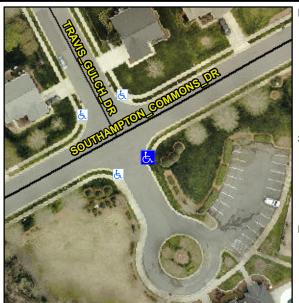
Not Found, R304.5.1, R304.5.3

Comp	liance Description	Data	Comp	liance	Description	Data
N/A	Ramp Length (in)	46.0	Yes	Ramp	Slope (%)	7.2
No	Ramp Width (in)	30.0	No	Ramp	XSlope (%)	6.4
N/A	Flare Type LT	N/A	N/A	Flare	Type RT	N/A
N/A	Flare Slope LT (%)	N/A	N/A	Flare	Slope RT (%)	N/A
N/A	Flare Traversable LT?	N/A	N/A	Flare	Traversable RT?	N/A
N/A	Landing Length (in)	N/A	N/A	DWS	Provided?	N/A
N/A	Landing Width (in)	N/A	N/A	DWS	Contrast?	N/A
N/A	Landing Slope (%)	N/A	N/A	DWS	Length (in)	N/A
N/A	Landing X Slope (%)	N/A	N/A	DWS	Full Width?	N/A
N/A	Landing Curb? (Y/N)	N/A	N/A	DWS	Offset (in)	N/A
N/A	Shared Landing?	N/A				
N/A	Gutter Ponding?	N/A	N/A	Gutte	r Slope (%)	N/A
N/A	Gutter Lip Ht (in)	N/A	N/A	Gutte	r X Slope (%)	N/A
N/A	Painted X Walk1?	No	N/A	Paint	ed X Walk2?	N/A
	X Walk 1 Direction	To W		X Wa	lk 2 Direction	N/A
N/A	X Walk 1 Width (in)	N/A	N/A	X Wa	lk 2 Width (in)	N/A
	X Walk 1 Slope (%)	4.8		X Wa	lk 2 Slope (%)	N/A
	X Walk 1 X Slope (%)	4.7		X Wa	lk 2 X Slope (%)	N/A

Remove & Replace Entire Ramp.

Total Cost: \$ 1850.00
