Access Compliance Report

Public Rights-of-Way

(Curb Ramps)

Intersection ID: 10154	Main Street: SLOAN_DR	Cross Street: TUCKASEEGEE_RD	Location: E
ADA ID: 5243DA4387A8	Ramp Type: Perp	Initial Pass/Fail: Fail	Overall Compliance: No
			Severity Score: 21.25

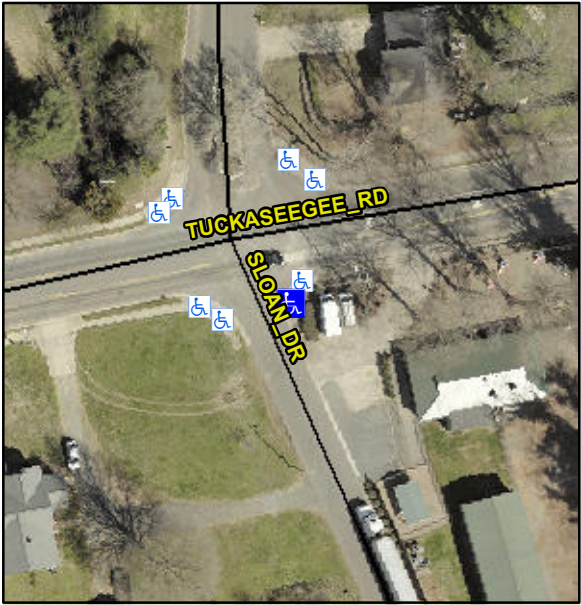
Possible Solutions:		Compliance	Description	Data
	Remove & Replace Entire Ramp.		No	Ramp Length (in)	59.5
			No	Ramp Width (in)	38.0
			N/A	Flare Type LT	N/A
			N/A	Flare Slope LT (%)	N/A
			N/A	Flare Traversable LT?	N/A
			N/A	Landing Length (in)	N/A
			N/A	Landing Width (in)	N/A
			N/A	Landing Slope (%)	N/A
			N/A	Landing X Slope (%)	N/A
<p>Surveyor Notes:</p> <p>N/A</p> <p>PROW/ADA:</p> <p>Not Found, R304.5.1, R304.2.2</p>			N/A	Flare Type RT	N/A
			N/A	Flare Slope RT (%)	N/A
			N/A	Flare Traversable RT?	N/A
			N/A	DWS Provided?	N/A
			N/A	DWS Contrast?	N/A
			N/A	DWS Length (in)	N/A
			N/A	DWS Full Width?	N/A
			N/A	DWS Offset (in)	N/A
			N/A	Gutter Ponding?	N/A
			N/A	Gutter Lip Ht (in)	N/A
			No	Painted X Walk1?	N/A
				X Walk 1 Direction	To W
			N/A	X Walk 1 Width (in)	N/A

4.9	X Walk 1 Slope (%)	N/A
			1.1	X Walk 1 X Slope (%)	N/A
			N/A	Ramp inside XWalk1?	N/A
			N/A	Road Slope (%)	N/A
			N/A	Road X Slope (%)	N/A
			N/A	Any Obstructions?	N/A
				Obstruction Type	
Total Cost: \$ 1850.00			N/A	Storm Grate/Utility Hazard?	N/A
			N/A	Storm Grate/Utility Type	N/A
			Yes	Surface Condition? (G/P)	Good
