Access Compliance Report Public Rights-of-Way (Curb Ramps)

Intersection ID: 9690Main Street:NORWOOD_DRCross Street:PARKWAY_AVLocation:WADA ID: 524B757843CCRamp Type:PerpInitial Pass/Fail:FailOverall Compliance:NoSeverity Score:27.5

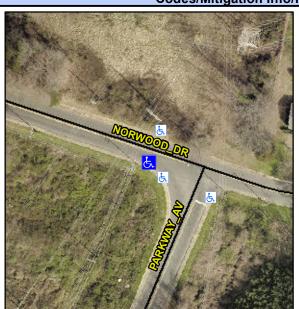
Field Measurements/Component Compliance							
Comp	liance Description	Data	Compl	liance	Description	Data	
N/A	Ramp Length (in)	38.5	No	Ramp	Slope (%)	9.6	
Yes	Ramp Width (in)	56.0	Yes	Ramp	XSlope (%)	0.4	
N/A	Flare Type LT	N/A	N/A	Flare	Type RT	N/A	
N/A	Flare Slope LT (%)	N/A	N/A	Flare	Slope RT (%)	N/A	
N/A	Flare Traversable LT?	N/A	N/A	Flare	Traversable RT?	N/A	
N/A	Landing Length (in)	N/A	N/A	DWS	Provided?	N/A	
N/A	Landing Width (in)	N/A	N/A	DWS	Contrast?	N/A	
N/A	Landing Slope (%)	N/A	N/A	DWS	Length (in)	N/A	
N/A	Landing X Slope (%)	N/A	N/A	DWS	Full Width?	N/A	
N/A	Landing Curb? (Y/N)	N/A	N/A	DWS	Offset (in)	N/A	
N/A	Shared Landing?	N/A					
N/A	Gutter Ponding?	Yes	N/A	Gutte	r Slope (%)	N/A	
N/A	Gutter Lip Ht (in)	N/A	N/A	Gutte	r X Slope (%)	N/A	
N/A	Painted X Walk1?	No	N/A	Painte	ed X Walk2?	N/A	
	X Walk 1 Direction	To NE		X Wa	lk 2 Direction	N/A	
N/A	X Walk 1 Width (in)	N/A	N/A	X Wa	lk 2 Width (in)	N/A

X Walk 1 Slope (%)	3.5		X Wa	lk 2 Slope (%)	N/A	
	X Walk 1 X Slope (%)	1.8		X Wa	lk 2 X Slope (%)	N/A	
N/A	Ramp inside XWalk1?	N/A	N/A	Ramp	inside XWalk2?	N/A	
	Road Slope (%)	N/A	N/A	Clear	Space?	N/A	
	Road X Slope (%)	N/A	N/A	Clear	Space to XWalk (in)	N/A	
N/A	Any Obstructions?	N/A	N/A	Storm	Grate/Utility Hazard?	N/A	
	Obstruction Type			Storm	Grate/Utility Type		
		N/A				N/A

Poor

Possible Solutions:	<u>c</u>	
Remove & Replace Entire Ramp.		
	Y	
	N	
	N	
	N	
	N	
Surveyor Notes:	N	
N/A	N	
	N	
	N	
	N	
PROW/ADA:	N	
Not Found, R304.2.2, R302.7	N	
	N	
	N

Total Cost: \$ 1850.00
