Access Compliance Report

Public Rights-of-Way

(Curb Ramps)

Intersection ID: 43843	Main Street: DELUCA_DR	Cross Street: ROTHMAN_LN	Location:	E
ADA ID: 524F618D2328	Ramp Type: Perp	Initial Pass/Fail: Fail	Overall Compliance: No	Severity Score: 8.75
Codes/Mitigation Info/Possible Solution		Field Measurements/Component Compliance

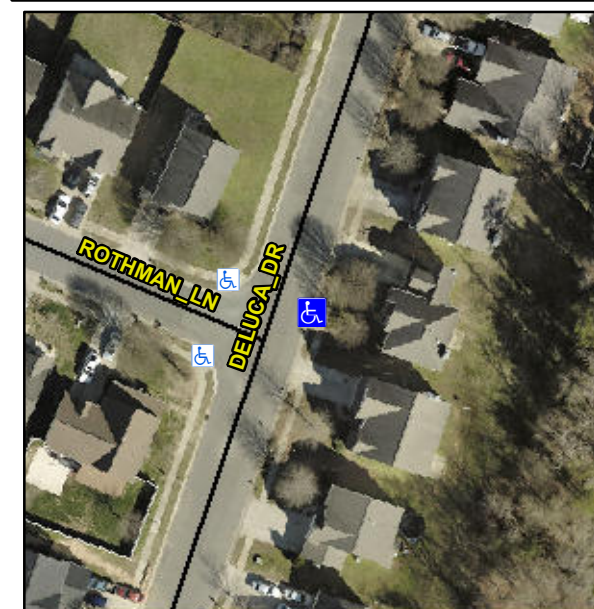
Not Found, R304.5.1

Compliance	Description	Data	Compliance	Description	Data
N/A	Ramp Length (in)	48.0	Yes	Ramp Slope (%)	7.7
No	Ramp Width (in)	47.0	Yes	Ramp XSlope (%)	1.1
N/A	Flare Type LT	N/A	N/A	Flare Type RT	N/A
N/A	Flare Slope LT (%)	N/A	N/A	Flare Slope RT (%)	N/A
N/A	Flare Traversable LT?	N/A	N/A	Flare Traversable RT?	N/A
N/A	Landing Length (in)	N/A	N/A	DWS Provided?	N/A
N/A	Landing Width (in)	N/A	N/A	DWS Contrast?	N/A
N/A	Landing Slope (%)	N/A	N/A	DWS Length (in)	N/A
N/A	Landing X Slope (%)	N/A	N/A	DWS Full Width?	N/A
N/A	Landing Curb? (Y/N)	N/A	N/A	DWS Offset (in)	N/A
N/A	Shared Landing?	N/A			
N/A	Gutter Ponding?	N/A	N/A	Gutter Slope (%)	N/A
N/A	Gutter Lip Ht (in)	N/A	N/A	Gutter X Slope (%)	N/A
N/A	Painted X Walk1?	No	N/A	Painted X Walk2?	N/A
	X Walk 1 Direction	To NW		X Walk 2 Direction	N/A
N/A	X Walk 1 Width (in)	N/A	N/A	X Walk 2 Width (in)	N/A
	X Walk 1 Slope (%)	1.1		X Walk 2 Slope (%)	N/A
	X Walk 1 X Slope (%)	1.3		X Walk 2 X Slope (%)	N/A

N/A	Ramp inside XWalk1?	N/A	N/A	Ramp inside XWalk2?	N/A
	Road Slope (%)	N/A	N/A	Clear Space?	N/A
	Road X Slope (%)	N/A	N/A	Clear Space to XWalk (in)	N/A
N/A	Any Obstructions?	N/A	N/A	Storm Grate/Utility Hazard?	N/A
	Obstruction Type			Storm Grate/Utility Type	
		N/A			N/A
			Yes	Surface Condition? (G/P)	Good

Possible Solutions:

Remove & Replace Entire Ramp.

Total Cost: \$ 1850.00
