Access Compliance Report Public Rights-of-Way (Curb Ramps)

Intersection ID: 10020762Main Street:BEATTIES_FORD_RDCross Street: N/ALocation:NWADA ID: 52596019EC3FRamp Type:ParaInitial Pass/Fail:FailOverall Compliance: NoSeverity Score:12.5

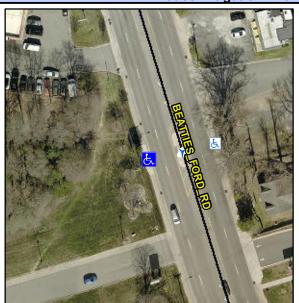
R304.3.2

Field Measurements Compliance Description Date			Comp	liance Description	Data
N/A	Ramp Length LT (in)	76.0	N/A	Ramp Length RT (in)	86.0
Yes	Ramp Width LT (in)	76.0	Yes	Ramp Width RT (in)	76.0
No	Ramp Slope LT (%)	8.4	Yes	Ramp Slope RT (%)	5.3
Yes	Ramp XSlope LT (%)	1.9	Yes	Ramp XSlope RT (%)	0.9
N/A	Landing Length (in)	N/A	N/A	DWS Provided?	N/A
N/A	Landing Width (in)	N/A	N/A	DWS Contrast?	N/A
N/A	Landing Slope (%)	N/A	N/A	DWS Length (in)	N/A
N/A	Landing X Slope (%)	N/A	N/A	DWS Full Width?	N/A
N/A	Landing Curb? (Y/N)	N/A	N/A	DWS Offset (in)	N/A
N/A	Shared Landing?	N/A		,	
N/A	Gutter Ponding?	N/A	N/A	Gutter Slope (%)	N/A
N/A	Gutter Lip Ht (in)	N/A	N/A	Gutter X Slope (%)	N/A
N/A	Painted X Walk1?	No	N/A	Painted X Walk2?	N/A
	X Walk 1 Direction	To NE		X Walk 2 Direction	N/A
N/A	X Walk 1 Width (in)	N/A	N/A	X Walk 2 Width (in)	N/A
	X Walk 1 Slope (%)	3.2		X Walk 2 Slope (%)	N/A
	X Walk 1 X Slope (%)	0.3		X Walk 2 X Slope (%)	N/A

Remove & Replace Entire Ramp.
