Access Compliance Report

Public Rights-of-Way

(Curb Ramps)

Intersection ID: 48462	Main Street: PANGLEMONT_DR	Cross Street: MITZI_DEBORAH_LN	Location: SW
ADA ID: 525E7544890F	Ramp Type: Perp	Initial Pass/Fail: Fail	Overall Compliance: No
Severity Score: 10			
Codes/Mitigation Info/Possible Solution		Field Measurements/Component Compliance

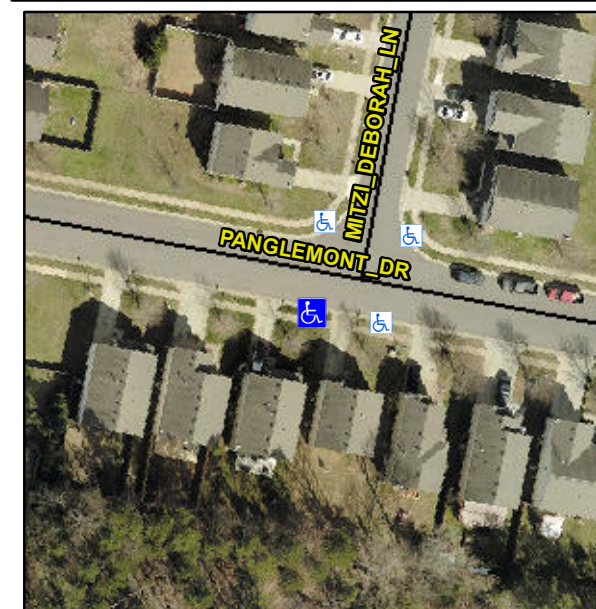
Not Found, R304.5.1, R304.5.3

Compliance	Description	Data	Compliance	Description	Data
N/A	Ramp Length (in)	47.0	Yes	Ramp Slope (%)	6.7
No	Ramp Width (in)	47.5	No	Ramp XSlope (%)	4.4
N/A	Flare Type LT	N/A	N/A	Flare Type RT	N/A
N/A	Flare Slope LT (%)	N/A	N/A	Flare Slope RT (%)	N/A
N/A	Flare Traversable LT?	N/A	N/A	Flare Traversable RT?	N/A
N/A	Landing Length (in)	N/A	N/A	DWS Provided?	N/A
N/A	Landing Width (in)	N/A	N/A	DWS Contrast?	N/A
N/A	Landing Slope (%)	N/A	N/A	DWS Length (in)	N/A
N/A	Landing X Slope (%)	N/A	N/A	DWS Full Width?	N/A
N/A	Landing Curb? (Y/N)	N/A	N/A	DWS Offset (in)	N/A
N/A	Shared Landing?	N/A			
N/A	Gutter Ponding?	N/A	N/A	Gutter Slope (%)	N/A
N/A	Gutter Lip Ht (in)	N/A	N/A	Gutter X Slope (%)	N/A
N/A	Painted X Walk1?	No	N/A	Painted X Walk2?	N/A
	X Walk 1 Direction	To N		X Walk 2 Direction	N/A
N/A	X Walk 1 Width (in)	N/A	N/A	X Walk 2 Width (in)	N/A
	X Walk 1 Slope (%)	2.9		X Walk 2 Slope (%)	N/A
	X Walk 1 X Slope (%)	4.0		X Walk 2 X Slope (%)	N/A

N/A	Ramp inside XWalk1?	N/A	N/A	Ramp inside XWalk2?	N/A
	Road Slope (%)	N/A	N/A	Clear Space?	N/A
	Road X Slope (%)	N/A	N/A	Clear Space to XWalk (in)	N/A
N/A	Any Obstructions?	N/A	N/A	Storm Grate/Utility Hazard?	N/A
	Obstruction Type			Storm Grate/Utility Type	
		N/A			N/A
			Yes	Surface Condition? (G/P)	Good

Remove & Replace Entire Ramp.

Total Cost: \$ 1850.00
