Access Compliance Report

Public Rights-of-Way

(Curb Ramps)

Intersection ID: 15324	Main Street: ELMHURST_RD	Cross Street: SOUTH_BV	Location: NE
ADA ID: 52653721D45A	Ramp Type: Directional1	Initial Pass/Fail: Fail	Overall Compliance: No
Severity Score: 1.25			
Codes/Mitigation Info/Possible Solution		Field Measurements/Component Compliance

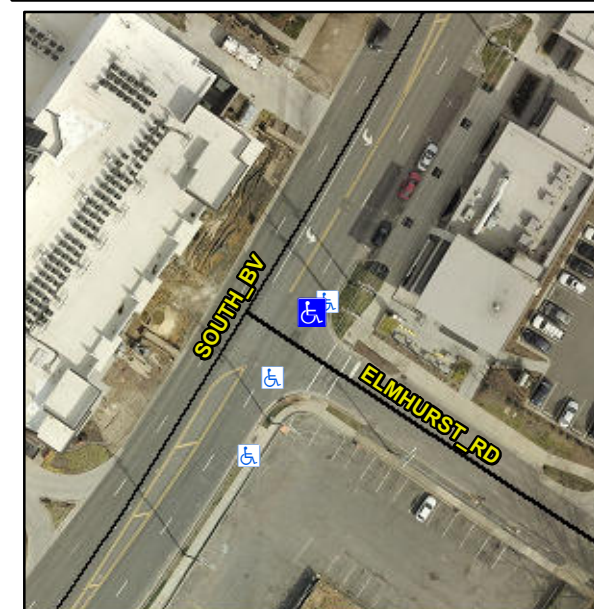
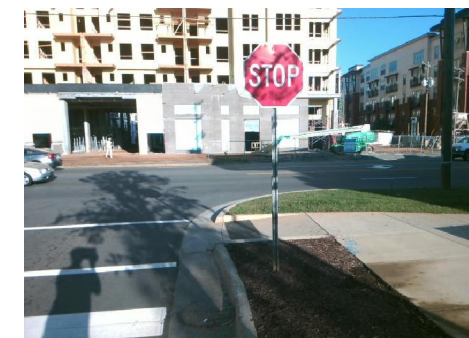
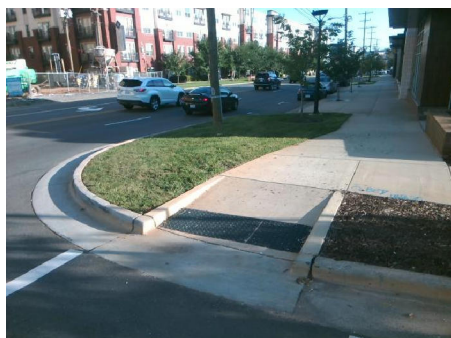
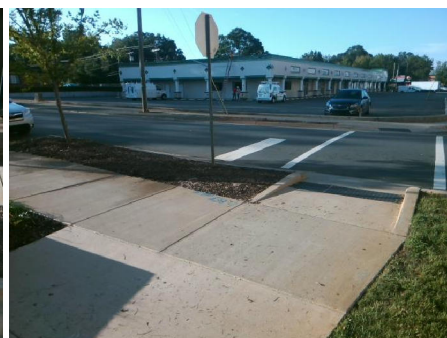
Compliance	Description	Data	Compliance	Description	Data
N/A	Ramp Length (in)	48.0	N/A	Grade Break?	N/A
Yes	Ramp Width (in)	72.0	N/A	Grade Break Slope (%)	0.0
Yes	Ramp Slope (%)	4.5	N/A	Grade Break XSlope (%)	0.0
No	Ramp XSlope (%)	2.1			
N/A	Flare Type LT	N/A	N/A	Flare Type RT	N/A
N/A	Flare Slope LT (%)	N/A	N/A	Flare Slope RT (%)	0.0
N/A	Flare Traversable LT?	N/A	N/A	Flare Traversable RT?	N/A
N/A	Landing Length (in)	0.0	N/A	DWS Provided?	N/A
N/A	Landing Width (in)	0.0	N/A	DWS Contrast?	N/A
N/A	Landing Slope (%)	0.0	N/A	DWS Length (in)	N/A
N/A	Landing X Slope (%)	0.0	N/A	DWS Full Width?	N/A
N/A	Landing Curb? (Y/N)	N/A	N/A	DWS Offset LT (in)	N/A
N/A	Shared Landing?	N/A	N/A	DWS Offset RT (in)	N/A
N/A	Gutter Ponding?	0.0	N/A	Gutter Slope (%)	N/A
N/A	Gutter Lip Ht (in)	0.0	N/A	Gutter X Slope (%)	N/A
N/A	Painted X Walk1?	Yes		Road Slope (%)	2.6
	X Walk 1 Direction	To S		Road X Slope (%)	1.5
	X Walk 1 Width (in)	112.0		Clear Space?	N/A

X Walk 1 Slope (%)	2.6	N/A	Clear Space to XWalk (in)	N/A
	X Walk 1 X Slope (%)	1.5	N/A	Storm Grate/Utility Hazard?	N/A
N/A	Ramp inside XWalk1?	Yes		Storm Grate/Utility Type	
N/A	Any Obstructions?	N/A			N/A
	Obstruction Type		Yes	Surface Condition? (G/P)	Good
			N/A	Curb Slope (%)	6.3

Possible Solutions:

Remove & Replace Entire Ramp.

PROW/ADA:

R304.5.3
