## **Access Compliance Report Public Rights-of-Way** (Curb Ramps)

Cross Street: BALLANTYNE VILLAGE WY Intersection ID: N/A Main Street: LABEAU AV Ε Location: **Severity Score: ADA ID: 5267FBE7718B** Ramp Type: PerpDiag Initial Pass/Fail: Fail **Overall Compliance: No** 8.75

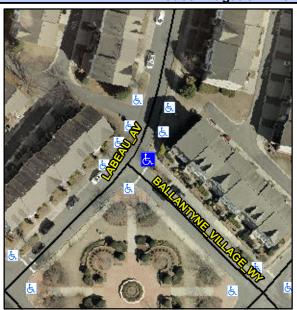
LABEAU AV Street 1 Name Stop Condition-Street 2 None **BALLANTYNE VILLAGE WY** Street 2 Name Stop Condition-Street 1 StopSign Possible Solutions: Remove & Replace Curb Ramp With Two New Directional Ramps or Equivalent. Surveyor Notes: N/A PROW/ADA: Not Found, R304.5.1
