## Access Compliance Report Public Rights-of-Way (Curb Ramps)

Intersection ID: 10029121Main Street: JAMES\_BLAKENEY\_AVCross Street: N/ALocation:SWADA ID: 526F062E31B7Ramp Type: PerpDiagInitial Pass/Fail: FailOverall Compliance: NoSeverity Score:25

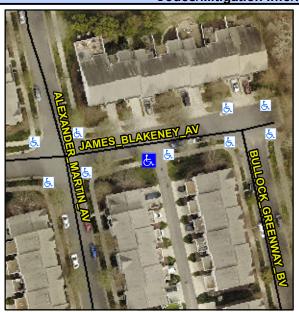
Field Measurements/Component Compliance								
	Compliance Description		Data	Comp	oliance Description	Data		
	N/A	Ramp Length (in)	63.0	No	Ramp Slope (%)	13.4		
	Yes	Ramp Width (in)	67.0	Yes	Ramp XSlope (%)	1.2		
	N/A	Flare Type LT	N/A	N/A	Flare Type RT	N/A		
	N/A	Flare Slope LT (%)	N/A	N/A	Flare Slope RT (%)	N/A		
	N/A	Flare Traversable LT?	N/A	N/A	Flare Traversable RT?	N/A		
	N/A	Landing Length (in)	N/A	N/A	DWS Provided?	N/A		
	N/A	Landing Width (in)	N/A	N/A	DWS Contrast?	N/A		
	N/A	Landing Slope (%)	N/A	N/A	DWS Length (in)	N/A		
	N/A	Landing X Slope (%)	N/A	N/A	DWS Full Width?	N/A		
	N/A	Landing Curb? (Y/N)	N/A	N/A	DWS Offset (in)	N/A		
	N/A	Shared Landing?	N/A					
	N/A	Gutter Ponding?	N/A	N/A	Gutter Slope (%)	N/A		
	N/A	Gutter Lip Ht (in)	N/A	N/A	Gutter X Slope (%)	N/A		
	N/A	Painted X Walk1?	No	N/A	Painted X Walk2?	No		
		X Walk 1 Direction	To E		X Walk 2 Direction	To N		
	N/A	X Walk 1 Width (in)	N/A	N/A	X Walk 2 Width (in)	N/A

X Walk 1 Slope (%)	1.4		X Walk 2 Slope (%)	0.5		
		X Walk 1 X Slope (%)	1.5		X Walk 2 X Slope (%)	1.4		
	N/A	Ramp inside XWalk1?	N/A	N/A	Ramp inside XWalk2?	N/A		
		Road Slope (%)	1.7	N/A	Clear Space?	N/A		
		Road X Slope (%)	2.1	N/A	Clear Space to XWalk (in)	N/A		
	N/A	Any Obstructions?	N/A	N/A	Storm Grate/Utility Hazard?	N/A		
		Obstruction Type			Storm Grate/Utility Type			
			N/A			N/A		
				Yes	Surface Condition? (G/P)	Good		
(thin)	ALCOHOLD THE	THE RESERVE OF THE PARTY OF THE

Possible Solutions:	C			
Remove & Replace Curb Ramp With				
Two New Directional Ramps or	Υe			
Equivalent.	N/			
	N/			
	N/			
	N/			
Surveyor Notes:	N/			
N/A	N/			
	N/			
	N/			
	N/			
PROW/ADA:	N/			
Not Found, R304.2.2	N/			
	N/			
	N/			
	N/
