Access Compliance Report

Public Rights-of-Way

(Curb Ramps)

Intersection ID: 20057		Main Street: ASSEMBLY_ST		Cross Street: BULFINCH_RD		Location: SE											
ADA ID: 5270752E7EEB		Ramp Type: Directional1		Initial Pass/Fail: Fail		Overall Compliance: No		Severity Score: 13.75									
Codes/Mitigation Info/Possible Solution				Field Measurements/Component Compliance													
<div>

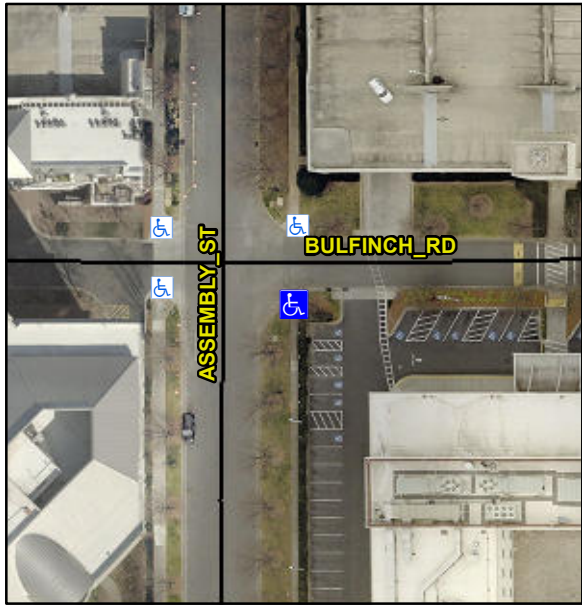
</div> <div>Street 1 NameBULFINCH RD</div> <div>Stop Condition-Street 1StopSign</div> <div>Street 2 NameN/A</div> <div>Stop Condition-Street 2N/A</div>				Possible Solutions:		Compliance		Description		Data		Compliance		Description		Data	
				Remove & Replace Entire Ramp.		N/A	Ramp Length (in)	91.0		N/A	Grade Break?	N/A					
						Yes	Ramp Width (in)	60.0		N/A	Grade Break Slope (%)	0.0					
						No	Ramp Slope (%)	9.4		N/A	Grade Break XSlope (%)	0.0					
						No	Ramp XSlope (%)	3.6									
						N/A	Flare Type LT	N/A		N/A	Flare Type RT	N/A					
						N/A	Flare Slope LT (%)	N/A		N/A	Flare Slope RT (%)	0.0

N/A	Flare Traversable LT?	N/A		N/A	Flare Traversable RT?	N/A					
						N/A	Landing Length (in)	0.0		N/A	DWS Provided?	N/A					
						N/A	Landing Width (in)	0.0		N/A	DWS Contrast?	N/A					
						N/A	Landing Slope (%)	0.0		N/A	DWS Length (in)	N/A					
						N/A	Landing X Slope (%)	0.0		N/A	DWS Full Width?	N/A					
						N/A	Landing Curb? (Y/N)	N/A		N/A	DWS Offset LT (in)	N/A					
		N/A	Shared Landing?	N/A		N/A	DWS Offset RT (in)	N/A									
		N/A	Gutter Ponding?	0.0		N/A	Gutter Slope (%)	N/A									
		N/A	Gutter Lip Ht (in)	0.0		N/A	Gutter X Slope (%)	N/A									
		N/A	Painted X Walk1?	No			Road Slope (%)	2.5									
			X Walk 1 Direction	To N			Road X Slope (%)	1.1									
			X Walk 1 Width (in)	N/A			Clear Space?	N/A									
			X Walk 1 Slope (%)	2.5		N/A	Clear Space to XWalk (in)	N/A									
			X Walk 1 X Slope (%)	1.1		N/A	Storm Grate/Utility Hazard?	N/A									
		N/A	Ramp inside XWalk1?	N/A			Storm Grate/Utility Type

N/A	Any Obstructions?	N/A				N/A									
			Obstruction Type			Yes	Surface Condition? (G/P)	Good									
						N/A	Curb Slope (%)	6.5									
		Total Cost:	\$	1600.00
