## **Access Compliance Report Public Rights-of-Way** (Curb Ramps)

Intersection ID: 12078 Main Street: MARLOWE AV **Cross Street: HIGHLAND ST** NE Location: **Overall Compliance: No Severity Score:** 12.5 ADA ID: 5274EE3F1D91 Ramp Type: Combination1 Initial Pass/Fail: Fail

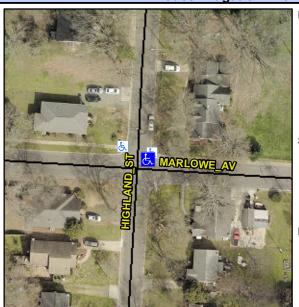
Street 1 Name StopSign Stop Condition-Street 1 **HIGHLAND ST** N/A Street 2 Name Stop Condition-Street 2 N/A Possible Solutions: Remove & Replace Entire Ramp. Surveyor Notes: **NO LT SW. RP < 5%** PROW/ADA Not Found, R304.5.1, R304.5.1, R304.5.3
