Access Compliance Report

Public Rights-of-Way

(Curb Ramps)

| Intersection ID: 13004 | Main Street: S_GRAHAM_ST | Cross Street: WINONA_ST | Location: | E |

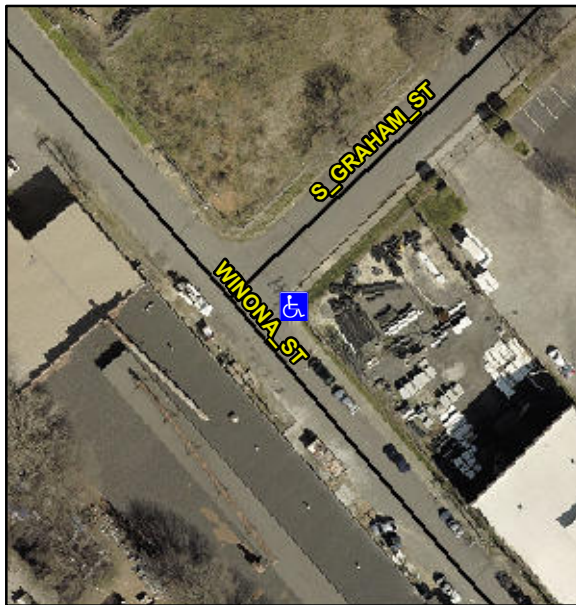
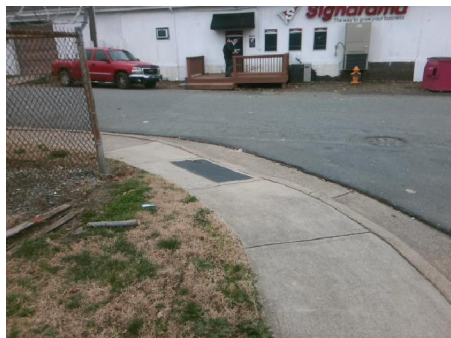
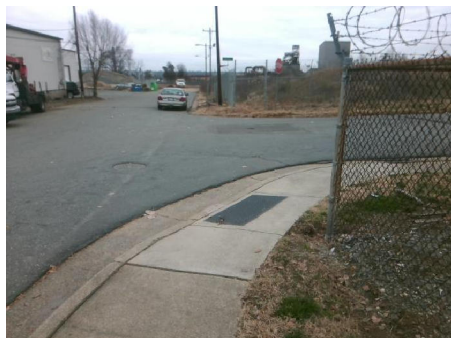
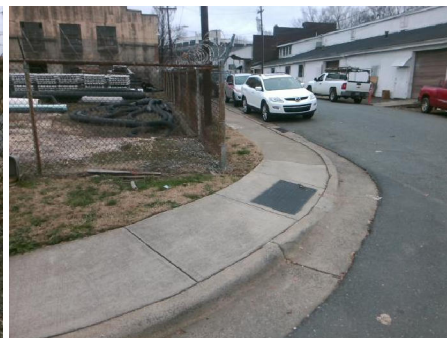
| ADA ID: 527AF1F064EE | Ramp Type: PerpDiag | Initial Pass/Fail: Fail | Overall Compliance: No | Severity Score: 25 |

Not Found, R304.2.2

| Compliance | Description | Data | Compliance | Description | Data |
|---|---|---|---|---|---|
| N/A | Ramp Length (in) | 48.0 | No | Ramp Slope (%) | 14.2 |

Remove & Replace Curb Ramp With Two New Directional Ramps or Equivalent.
