# Access Compliance Report

## Public Rights-of-Way

### (Curb Ramps)

Intersection ID: 15813	Main Street: QUEENS_RD_WEST	Cross Street: ROLSTON_DR	Location: NE
ADA ID: 5281914A74D2	Ramp Type: Directional1	Initial Pass/Fail: Fail	Overall Compliance: No
Codes/Mitigation Info/Possible Solution		Field Measurements/Component Compliance

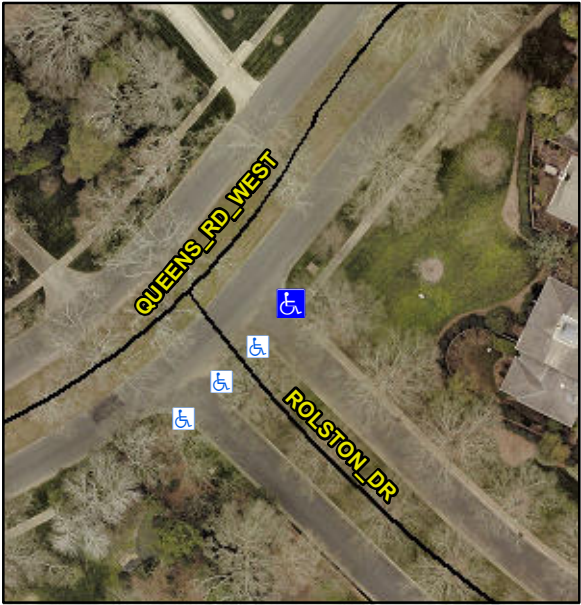
Possible Solutions:		Compliance		Description		Data	Compliance	Description	Data
	Remove & Replace Entire Ramp.		N/A		Ramp Length (in)		38.0	N/A	Grade Break?	N/A
<p>Surveyor Notes:</p> <p>N/A</p>	PROW/ADA:		N/A		Ramp Width (in)		48.0	N/A	Grade Break Slope (%)	0.0
	R304.2.2, R304.5.3		N/A		Ramp Slope (%)		9.5	N/A	Grade Break XSlope (%)	0.0
<p>Street 1 Name</p> <p>Stop Condition-Street 1</p> <p>Street 2 Name</p> <p>Stop Condition-Street 2</p>	Total Cost:		\$	1600.00	Ramp XSlope (%)		5.0	N/A	Flare Type RT	N/A
					Flare Type LT		N/A	N/A	Flare Slope RT (%)	0.0
					Flare Slope LT (%)		N/A	N/A	Flare Traversable RT?	N/A
					Flare Traversable LT?		N/A	N/A	DWS Provided?	N/A
					Landing Length (in)		0.0	N/A	DWS Contrast?	N/A
					Landing Width (in)		0.0	N/A	DWS Length (in)	N/A
					Landing Slope (%)		0.0	N/A	DWS Full Width?	N/A
					Landing X Slope (%)		0.0	N/A	DWS Offset LT (in)	N/A
					Landing Curb? (Y/N)		N/A	N/A	DWS Offset RT (in)	N/A

Shared Landing?		N/A	N/A	Gutter Slope (%)	N/A
					Gutter Ponding?		0.0	N/A	Gutter X Slope (%)	N/A
					Gutter Lip Ht (in)		2.0	N/A	Road Slope (%)	1.6
					Painted X Walk1?		No		Road X Slope (%)	2.8
					X Walk 1 Direction	To SW			Clear Space?	N/A
					X Walk 1 Width (in)		N/A		Clear Space to XWalk (in)	N/A
					X Walk 1 Slope (%)		1.6	N/A	Storm Grate/Utility Hazard?	N/A
					X Walk 1 X Slope (%)		2.8	N/A	Storm Grate/Utility Type	
					Ramp inside XWalk1?		N/A		Surface Condition? (G/P)	Good
					Any Obstructions?		N/A		Curb Slope (%)	24.1
					Obstruction Type
