# Access Compliance Report

## Public Rights-of-Way

### (Curb Ramps)

Intersection ID: N/A	Main Street: FINCHER_FARM_RD	Cross Street: N/A	Location: SE
ADA ID: 5293C009AA7B	Ramp Type: PerpDiag	Initial Pass/Fail: Fail	Overall Compliance: No
Codes/Mitigation Info/Possible Solution		Field Measurements/Component Compliance	
Severity Score: 12.5

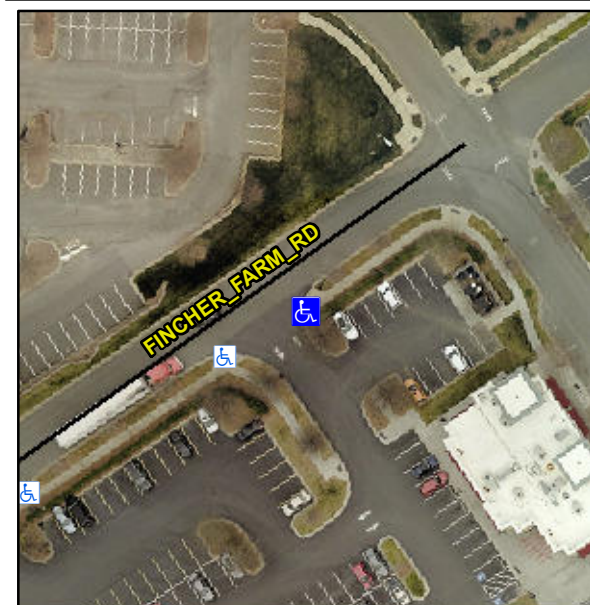
**Not Found, R304.2.2**

Compliance	Description	Data	Compliance	Description	Data
N/A	Ramp Length (in)	67.0	No	Ramp Slope (%)	9.7
Yes	Ramp Width (in)	48.0	Yes	Ramp XSlope (%)	0.6
N/A	Flare Type LT	N/A	N/A	Flare Type RT	N/A
N/A	Flare Slope LT (%)	N/A	N/A	Flare Slope RT (%)	N/A
N/A	Flare Traversable LT?	N/A	N/A	Flare Traversable RT?	N/A
N/A	Landing Length (in)	N/A	N/A	DWS Provided?	N/A
N/A	Landing Width (in)	N/A	N/A	DWS Contrast?	N/A
N/A	Landing Slope (%)	N/A	N/A	DWS Length (in)	N/A
N/A	Landing X Slope (%)	N/A	N/A	DWS Full Width?	N/A
N/A	Landing Curb? (Y/N)	N/A	N/A	DWS Offset (in)	N/A
N/A	Shared Landing?	N/A			
N/A	Gutter Ponding?	N/A	N/A	Gutter Slope (%)	N/A
N/A	Gutter Lip Ht (in)	N/A	N/A	Gutter X Slope (%)	N/A
N/A	Painted X Walk1?	No	N/A	Painted X Walk2?	No
	X Walk 1 Direction	To NW		X Walk 2 Direction	To SW
N/A	X Walk 1 Width (in)	N/A	N/A	X Walk 2 Width (in)	N/A
	X Walk 1 Slope (%)	2.3		X Walk 2 Slope (%)	2.0
	X Walk 1 X Slope (%)	2.7		X Walk 2 X Slope (%)	2.5

N/A	Ramp inside XWalk1?	N/A	N/A	Ramp inside XWalk2?	N/A
	Road Slope (%)	1.3	N/A	Clear Space?	N/A
	Road X Slope (%)	2.2	N/A	Clear Space to XWalk (in)	N/A
N/A	Any Obstructions?	N/A	N/A	Storm Grate/Utility Hazard?	N/A
	Obstruction Type			Storm Grate/Utility Type	
		N/A			N/A
			Yes	Surface Condition? (G/P)	Good

Possible Solutions:

**Remove & Replace Curb Ramp With Two New Directional Ramps or Equivalent.**
