Access Compliance Report

Public Rights-of-Way

(Curb Ramps)

Intersection ID: 2891	Main Street: BEAROAK_LN	Cross Street: RIDGEFIELD_DR	Location:	N
ADA ID: 5294A8B538B1	Ramp Type: Perp	Initial Pass/Fail: Fail	Overall Compliance: No	Severity Score: 8.75
Codes/Mitigation Info/Possible Solution		Field Measurements/Component Compliance

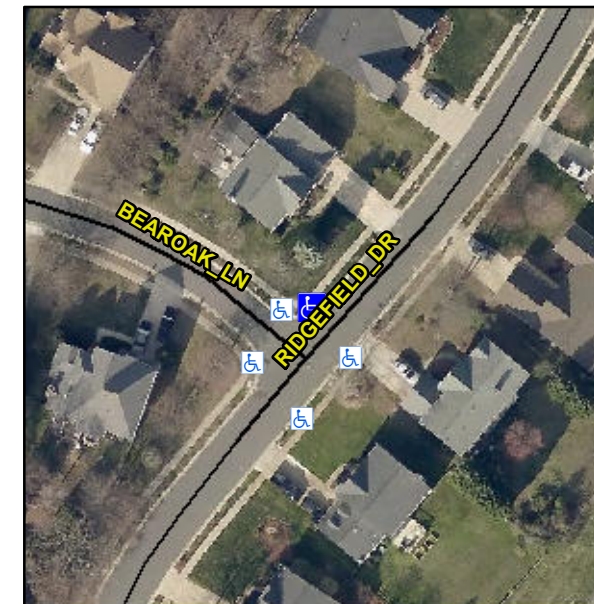
Compliance	Description	Data	Compliance	Description	Data
N/A	Ramp Length (in)	47.0	Yes	Ramp Slope (%)	7.4
No	Ramp Width (in)	38.0	Yes	Ramp XSlope (%)	1.6
N/A	Flare Type LT	N/A	N/A	Flare Type RT	N/A
N/A	Flare Slope LT (%)	N/A	N/A	Flare Slope RT (%)	N/A
N/A	Flare Traversable LT?	N/A	N/A	Flare Traversable RT?	N/A
N/A	Landing Length (in)	N/A	N/A	DWS Provided?	N/A
N/A	Landing Width (in)	N/A	N/A	DWS Contrast?	N/A
N/A	Landing Slope (%)	N/A	N/A	DWS Length (in)	N/A
N/A	Landing X Slope (%)	N/A	N/A	DWS Full Width?	N/A
N/A	Landing Curb? (Y/N)	N/A	N/A	DWS Offset (in)	N/A
N/A	Shared Landing?	N/A			
N/A	Gutter Ponding?	N/A	N/A	Gutter Slope (%)	N/A
N/A	Gutter Lip Ht (in)	N/A	N/A	Gutter X Slope (%)	N/A
N/A	Painted X Walk1?	No	N/A	Painted X Walk2?	N/A
	X Walk 1 Direction	To SE		X Walk 2 Direction	N/A
N/A	X Walk 1 Width (in)	N/A	N/A	X Walk 2 Width (in)	N/A
	X Walk 1 Slope (%)	4.1		X Walk 2 Slope (%)	N/A
	X Walk 1 X Slope (%)	0.0		X Walk 2 X Slope (%)	N/A

N/A	Ramp inside XWalk1?	N/A	N/A	Ramp inside XWalk2?	N/A
	Road Slope (%)	N/A	N/A	Clear Space?	N/A
	Road X Slope (%)	N/A	N/A	Clear Space to XWalk (in)	N/A
N/A	Any Obstructions?	N/A	N/A	Storm Grate/Utility Hazard?	N/A
	Obstruction Type			Storm Grate/Utility Type	
		N/A			N/A
			Yes	Surface Condition? (G/P)	Good

Possible Solutions:

Remove & Replace Entire Ramp.

R304.5.1
