Access Compliance Report

Public Rights-of-Way

(Curb Ramps)

Intersection ID: 14501	Main Street: BALDWIN_AV	Cross Street: ELLISON_ST	Location:	N
ADA ID: 529DC6D7246F	Ramp Type: PerpDiag	Initial Pass/Fail: Fail	Overall Compliance: No	Severity Score: 12.5

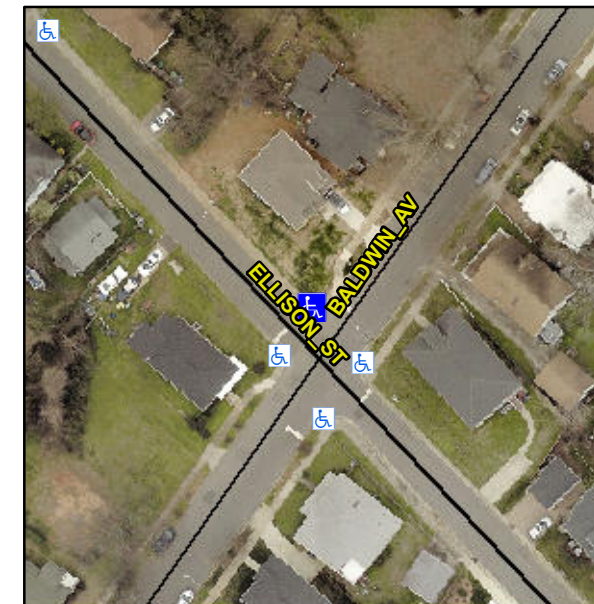
Not Found, R304.2.2

Compliance	Description	Data	Compliance	Description	Data
N/A	Ramp Length (in)	59.0	No	Ramp Slope (%)	11.0
Yes	Ramp Width (in)	48.0	Yes	Ramp XSlope (%)	0.5
N/A	Flare Type LT	N/A	N/A	Flare Type RT	N/A
N/A	Flare Slope LT (%)	N/A	N/A	Flare Slope RT (%)	N/A
N/A	Flare Traversable LT?	N/A	N/A	Flare Traversable RT?	N/A
N/A	Landing Length (in)	N/A	N/A	DWS Provided?	N/A
N/A	Landing Width (in)	N/A	N/A	DWS Contrast?	N/A
N/A	Landing Slope (%)	N/A	N/A	DWS Length (in)	N/A
N/A	Landing X Slope (%)	N/A	N/A	DWS Full Width?	N/A
N/A	Landing Curb? (Y/N)	N/A	N/A	DWS Offset (in)	N/A
N/A	Shared Landing?	N/A			
N/A	Gutter Ponding?	N/A	N/A	Gutter Slope (%)	N/A
N/A	Gutter Lip Ht (in)	N/A	N/A	Gutter X Slope (%)	N/A
N/A	Painted X Walk1?	No	N/A	Painted X Walk2?	No
	X Walk 1 Direction	To SW		X Walk 2 Direction	To SE
N/A	X Walk 1 Width (in)	N/A	N/A	X Walk 2 Width (in)	N/A
	X Walk 1 Slope (%)	1.4		X Walk 2 Slope (%)	1.1
	X Walk 1 X Slope (%)	0.4		X Walk 2 X Slope (%)	1.5

N/A	Ramp inside XWalk1?	N/A	N/A	Ramp inside XWalk2?	N/A
	Road Slope (%)	1.8	N/A	Clear Space?	N/A
	Road X Slope (%)	1.6	N/A	Clear Space to XWalk (in)	N/A
N/A	Any Obstructions?	N/A	N/A	Storm Grate/Utility Hazard?	N/A
	Obstruction Type			Storm Grate/Utility Type	
		N/A			N/A
		Yes		Surface Condition? (G/P)	Good

Remove & Replace Curb Ramp With Two New Directional Ramps or Equivalent.
