Access Compliance Report

Public Rights-of-Way

(Curb Ramps)

Intersection ID: 15498	Main Street: ORDERMORE_AV	Cross Street: PARK_RD	Location: SE
ADA ID: 52A768539E38	Ramp Type: Directional1	Initial Pass/Fail: Fail	Overall Compliance: No
Severity Score: 1.25			
Codes/Mitigation Info/Possible Solution		Field Measurements/Component Compliance

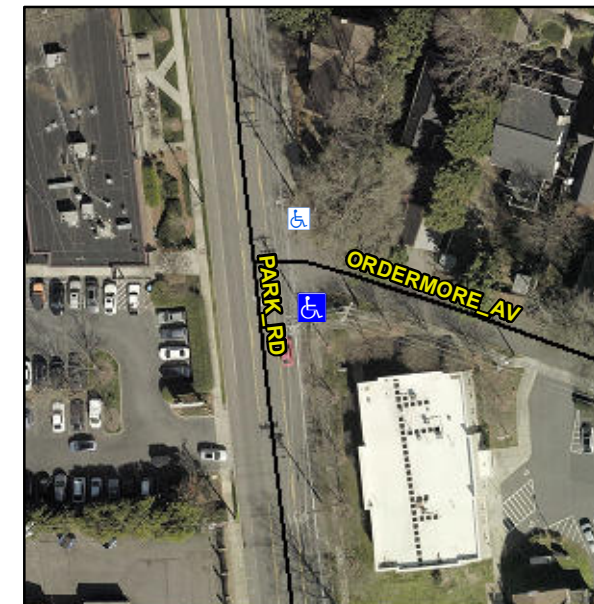
ASP LIP 1.0"

R304.5.3

Compliance	Description	Data	Compliance	Description	Data
N/A	Ramp Length (in)	81.0	N/A	Grade Break?	N/A
Yes	Ramp Width (in)	50.0	N/A	Grade Break Slope (%)	0.0
Yes	Ramp Slope (%)	1.8	N/A	Grade Break XSlope (%)	0.0
No	Ramp XSlope (%)	3.3			
N/A	Flare Type LT	N/A	N/A	Flare Type RT	N/A
N/A	Flare Slope LT (%)	N/A	N/A	Flare Slope RT (%)	0.0
N/A	Flare Traversable LT?	N/A	N/A	Flare Traversable RT?	N/A
N/A	Landing Length (in)	0.0	N/A	DWS Provided?	N/A
N/A	Landing Width (in)	0.0	N/A	DWS Contrast?	N/A
N/A	Landing Slope (%)	0.0	N/A	DWS Length (in)	N/A
N/A	Landing X Slope (%)	0.0	N/A	DWS Full Width?	N/A
N/A	Landing Curb? (Y/N)	N/A	N/A	DWS Offset LT (in)	N/A
N/A	Shared Landing?	N/A	N/A	DWS Offset RT (in)	N/A
N/A	Gutter Ponding?	0.0	N/A	Gutter Slope (%)	N/A
N/A	Gutter Lip Ht (in)	0.0	N/A	Gutter X Slope (%)	N/A
N/A	Painted X Walk1?	No		Road Slope (%)	4.9
	X Walk 1 Direction	To NW		Road X Slope (%)	7.4
	X Walk 1 Width (in)	N/A		Clear Space?	N/A

X Walk 1 Slope (%)	4.9	N/A	Clear Space to XWalk (in)	N/A
	X Walk 1 X Slope (%)	7.4	N/A	Storm Grate/Utility Hazard?	N/A
N/A	Ramp inside XWalk1?	N/A		Storm Grate/Utility Type	
N/A	Any Obstructions?	N/A			N/A
	Obstruction Type		Yes	Surface Condition? (G/P)	Good
			N/A	Curb Slope (%)	16.6

Remove & Replace Entire Ramp.

\$ 1600.00
