## **Access Compliance Report Public Rights-of-Way** (Curb Ramps)

Intersection ID: 44167 Main Street: BRANDYBUCK LN **Cross Street: COCHRANE DR** Location: NW **Overall Compliance: No Severity Score:** 35 ADA ID: 52AFB4E9BD5C Ramp Type: BlendTrans1 Initial Pass/Fail: Fail

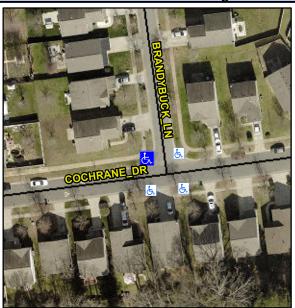
Total Cost: 3200.00 Compliance Description Data Compliance Description Data Ramp Length (in) Yes BlendTrans Slope (%) N/A 84.5 4.6 Yes No Ramp Width (in) 28.0 BlendTrans XSlope (%) 1.0 N/A N/A Flare Type LT N/A Flare Type RT N/A N/A Flare Slope LT (%) N/A N/A Flare Slope RT (%) N/A N/A Flare Traversable LT? N/A N/A Flare Traversable RT? N/A N/A Landing Length (in) N/A N/A **DWS Provided?** N/A N/A Landing Width (in) N/A N/A **DWS Contrast?** N/A N/A N/A N/A Landing Slope (%) DWS Length (in) N/A N/A Landing X Slope (%) N/A N/A DWS Full Width? N/A N/A Landing Curb? (Y/N) N/A N/A DWS Offset (in) N/A N/A N/A Shared Landing? N/A **Gutter Ponding?** N/A N/A Gutter Slope (%) N/A N/A Gutter Lip Ht (in) N/A N/A Gutter X Slope (%) N/A N/A Painted X Walk1? No N/A Painted X Walk2? No X Walk 1 Direction To S X Walk 2 Direction To E N/A X Walk 1 Width (in) X Walk 2 Width (in) N/A X Walk 1 Slope (%) 0.8 X Walk 2 Slope (%) 2.1 X Walk 1 X Slope (%) 2.3 X Walk 2 X Slope (%) 0.3 N/A N/A Ramp inside XWalk2? N/A N/A Ramp inside XWalk1? Road Slope (%) 2.4 Clear Space? N/A Road X Slope (%) 0.8 N/A Clear Space to XWalk (in) N/A N/A N/A N/A Any Obstructions? Storm Grate/Utility Hazard? N/A

**COCHRANE DR** None **BRANDYBUCK LN** StopSign Possible Solutions: Remove & Replace Curb Ramp With Two New Directional Ramps or Equivalent. Surveyor Notes: N/A PROW/ADA: Not Found, R304.5.1
