Access Compliance Report Public Rights-of-Way (Curb Ramps)

Intersection ID: 7982Main Street: BIG_HORN_CRCross Street: DAVID_AVLocation:N/AADA ID: 52B185853030Ramp Type: PerpInitial Pass/Fail: FailOverall Compliance: NoSeverity Score: 21.25

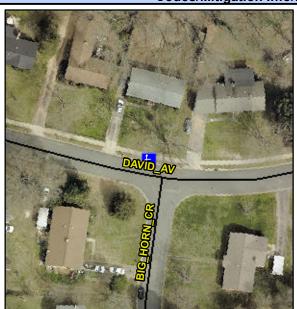
Field Measurements/Component Compliance						
Comp	oliance Description	Data	Comp	liance Description	Data	
N/A	Ramp Length (in)	46.5	No	Ramp Slope (%)	11.1	
No	Ramp Width (in)	47.0	Yes	Ramp XSlope (%)	1.9	
N/A	Flare Type LT	N/A	N/A	Flare Type RT	N/A	
N/A	Flare Slope LT (%)	N/A	N/A	Flare Slope RT (%)	N/A	
N/A	Flare Traversable LT?	N/A	N/A	Flare Traversable RT?	N/A	
N/A	Landing Length (in)	N/A	N/A	DWS Provided?	N/A	
N/A	Landing Width (in)	N/A	N/A	DWS Contrast?	N/A	
N/A	Landing Slope (%)	N/A	N/A	DWS Length (in)	N/A	
N/A	Landing X Slope (%)	N/A	N/A	DWS Full Width?	N/A	
N/A	Landing Curb? (Y/N)	N/A	N/A	DWS Offset (in)	N/A	
N/A	Shared Landing?	N/A				
N/A	Gutter Ponding?	N/A	N/A	Gutter Slope (%)	N/A	
N/A	Gutter Lip Ht (in)	1.5	N/A	Gutter X Slope (%)	N/A	
N/A	Painted X Walk1?	No	N/A	Painted X Walk2?	N/A	
	X Walk 1 Direction	To S		X Walk 2 Direction	N/A	
N/A	X Walk 1 Width (in)	N/A	N/A	X Walk 2 Width (in)	N/A	
	X Walk 1 Slope (%)	6.4		X Walk 2 Slope (%)	N/A

X Walk 1 X Slope (%)	2.9		X Walk 2 X Slope (%)	N/A	
N/A	Ramp inside XWalk1?	N/A	N/A	Ramp inside XWalk2?	N/A	
	Road Slope (%)	2.9	N/A	Clear Space?	N/A	
	Road X Slope (%)	6.4	N/A	Clear Space to XWalk (in)	N/A	
N/A	Any Obstructions?	N/A	N/A	Storm Grate/Utility Hazard?	N/A	
	Obstruction Type		l	Storm Grate/Utility Type		
		N/A			N/A	
			Yes	Surface Condition? (G/P)	Good	
	A Committee of

Possible Solutions:					
Remove & Replace Entire Ramp.					
	I				
	-				
Surveyor Notes:					
N/A					
PROW/ADA:					
Not Found, R304.5.1, R304.2.2	ı				
Not i odiid, 1304.5.1, 1304.2.2					
	1				
	1
