Access Compliance Report

Public Rights-of-Way

(Curb Ramps)

Intersection ID: N/A	Main Street: CALABASSAS LN	Cross Street: NORTHWEST PWY	Location: NE
ADA ID: 52BCD95C83B5	Ramp Type: PerpDiag	Initial Pass/Fail: Fail	Overall Compliance: No
Codes/Mitigation Info/Possible Solution		Field Measurements/Component Compliance

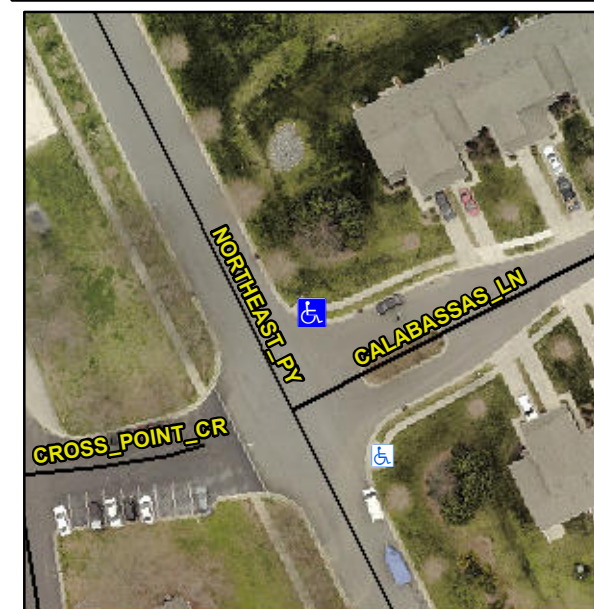
Compliance	Description	Data	Compliance	Description	Data
N/A	Ramp Length (in)	47.0	Yes	Ramp Slope (%)	7.2
No	Ramp Width (in)	42.0	Yes	Ramp XSlope (%)	0.3
N/A	Flare Type LT	N/A	N/A	Flare Type RT	N/A
N/A	Flare Slope LT (%)	N/A	N/A	Flare Slope RT (%)	N/A
N/A	Flare Traversable LT?	No	N/A	Flare Traversable RT?	No
N/A	Landing Length (in)	N/A	N/A	DWS Provided?	N/A
N/A	Landing Width (in)	N/A	N/A	DWS Contrast?	N/A
N/A	Landing Slope (%)	N/A	N/A	DWS Length (in)	N/A
N/A	Landing X Slope (%)	N/A	N/A	DWS Full Width?	N/A
N/A	Landing Curb? (Y/N)	N/A	N/A	DWS Offset (in)	N/A
N/A	Shared Landing?	N/A			
N/A	Gutter Ponding?	N/A	N/A	Gutter Slope (%)	N/A
N/A	Gutter Lip Ht (in)	N/A	N/A	Gutter X Slope (%)	N/A
N/A	Painted X Walk1?	No	N/A	Painted X Walk2?	No
	X Walk 1 Direction	To W		X Walk 2 Direction	To S
N/A	X Walk 1 Width (in)	N/A	N/A	X Walk 2 Width (in)	N/A
	X Walk 1 Slope (%)	2.4		X Walk 2 Slope (%)	1.1
	X Walk 1 X Slope (%)	0.8		X Walk 2 X Slope (%)	1.6

N/A	Ramp inside XWalk1?	N/A	N/A	Ramp inside XWalk2?	N/A
	Road Slope (%)	0.3	N/A	Clear Space?	N/A
	Road X Slope (%)	3.6	N/A	Clear Space to XWalk (in)	N/A
N/A	Any Obstructions?	N/A	N/A	Storm Grate/Utility Hazard?	N/A
	Obstruction Type			Storm Grate/Utility Type	
		N/A			N/A
			Yes	Surface Condition? (G/P)	Good

Possible Solutions:

Remove & Replace Curb Ramp With Two New Directional Ramps or Equivalent.

R304.5.1

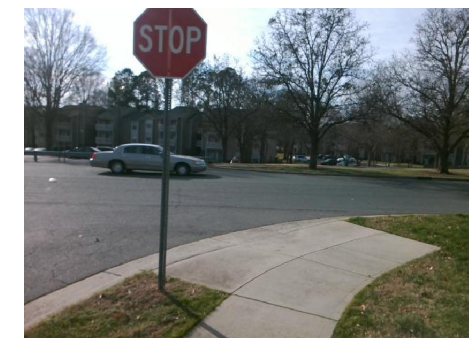
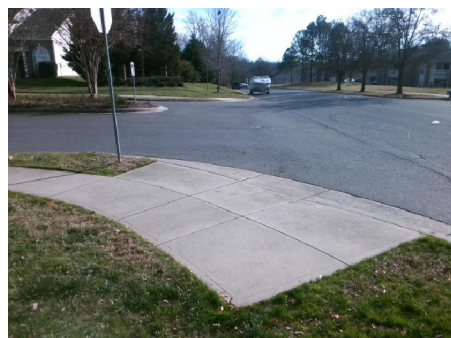
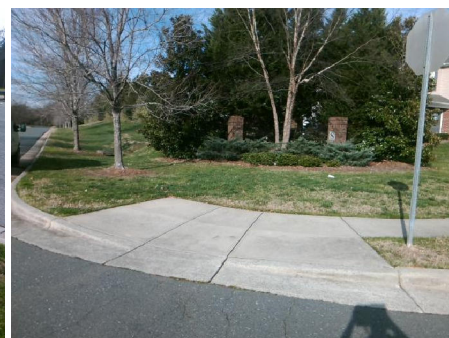
Street 1 Name **NORTHEAST PWY**
 Stop Condition-Street 2 **None**
 Street 2 Name **CALABASSAS LN**
 Stop Condition-Street 1 **StopSign**
