## Access Compliance Report Public Rights-of-Way (Curb Ramps)

Intersection ID: 48071	Main Street: STUB_ST		Cross Street: RED_VULCAN_CT					Location:	SE
ADA ID: 52EE48DEBB94	Ramp Type: PerpDiag			Initial Pass/Fail: Fail Overall Compliance: No				o Severity Score:	33.75
Codes/Mitigation Info/Possible Solution				Field Measurements/Component Compliance					
		Possible Solutions:		Compliance Description			Data Compliance Description		
	"白戸	Remove & Replace Curb Ramp W	/ith	N/A	Ramp Length (in)	48.0	Yes	Ramp Slope (%)	7.6
11 There are a		Two New Directional Ramps or		No	Ramp Width (in)	47.0	No	Ramp XSlope (%)	12.4
		Equivalent.		N/A	Flare Type LT	N/A	N/A	Flare Type RT	N/A
the second				N/A	Flare Slope LT (%)	N/A	N/A	Flare Slope RT (%)	N/A
	The second			N/A	Flare Traversable LT?	N/A	N/A	Flare Traversable RT?	N/A
ANDUV_CER				N/A	Landing Length (in)	N/A	N/A	DWS Provided?	N/A
		Surveyor Notes:		N/A	Landing Width (in)	N/A	N/A	DWS Contrast?	N/A
ti de la competencia de la com		N/A		N/A	Landing Slope (%)	N/A	N/A	DWS Length (in)	N/A

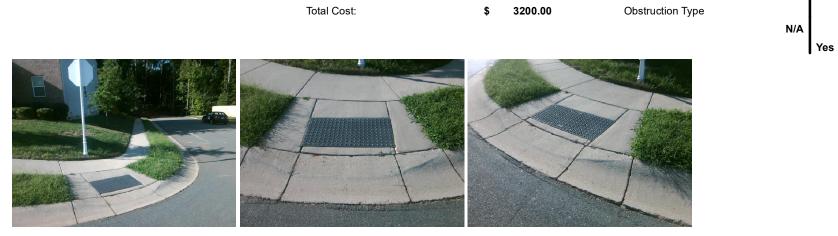
N/A	Landing X Slope (%)	N/A	N/A	DWS Full Width?	N/A
	the part of the			N/A	Landing Curb? (Y/N)	N/A	N/A	DWS Offset (in)	N/A
				N/A	Shared Landing?	N/A			
	All Sum	PROW/ADA:		N/A	Gutter Ponding?	N/A	N/A	Gutter Slope (%)	N/A
		Not Found, R304.5.1, R304.5.3		N/A	Gutter Lip Ht (in)	N/A	N/A	Gutter X Slope (%)	N/A
	and the second second	,,		N/A	Painted X Walk1?	No	N/A	Painted X Walk2?	No
					X Walk 1 Direction	To N		X Walk 2 Direction	To W
				N/A	X Walk 1 Width (in)	N/A	N/A	X Walk 2 Width (in)	N/A
Street 1 Name	<b>RED VULCAN CT</b>				X Walk 1 Slope (%)	4.9		X Walk 2 Slope (%)	2.6
Stop Condition-Street 2	None				X Walk 1 X Slope (%)	5.4		X Walk 2 X Slope (%)	8.3
Street 2 Name	STUB ST			N/A	Ramp inside XWalk1?	N/A	N/A	Ramp inside XWalk2?	N/A
Stop Condition-Street 1	StopSign				Road Slope (%)	9.7	N/A	Clear Space?	N/A
					Road X Slope (%)	5.6	N/A	Clear Space to XWalk (in)	N/A
				N/A	Any Obstructions?	N/A	N/A	Storm Grate/Utility Hazard?	N/A

Total Cost: \$ 32	200.00		Obstruction Type			Storm Grate/Utility Type	
						N/A			N/A
