# Access Compliance Report

## Public Rights-of-Way

### (Curb Ramps)

| Intersection ID: 14159 | Main Street: LAWRENCE_ORR_RD | Cross Street: SUN_RAY_CT | Location: | N |

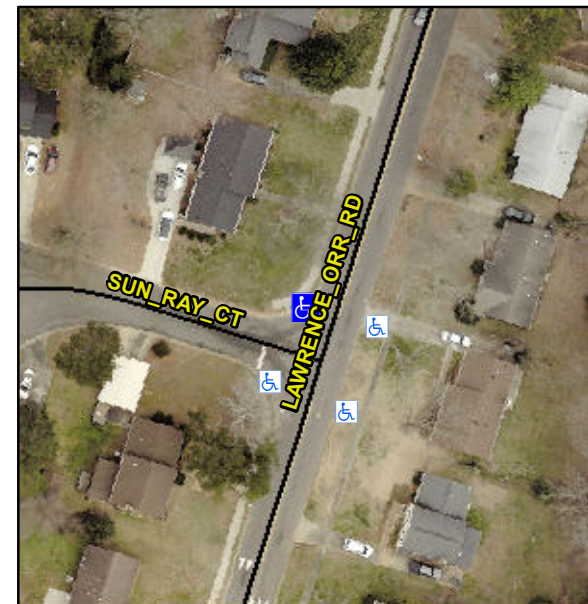
| ADA ID: 530363D006E0 | Ramp Type: PerpDiag | Initial Pass/Fail: Fail | Overall Compliance: No | Severity Score: 8.75 |

**Not Found, R304.5.1**

| Compliance | Description | Data | Compliance | Description | Data |
|---|---|---|---|---|---|
| No | Ramp Width (in) | 47.5 | Yes | Ramp XSlope (%) | 0.8 |

**Remove & Replace Curb Ramp With Two New Directional Ramps or Equivalent.**
