# Access Compliance Report

## Public Rights-of-Way

### (Curb Ramps)

Intersection ID: 49008	Main Street: FARM_LN	Cross Street: STEELECROFT_PY	Location: SE
ADA ID: 531817DB6C96	Ramp Type: Perp	Initial Pass/Fail: Fail	Overall Compliance: No
Codes/Mitigation Info/Possible Solution		Field Measurements/Component Compliance	
Severity Score: 10

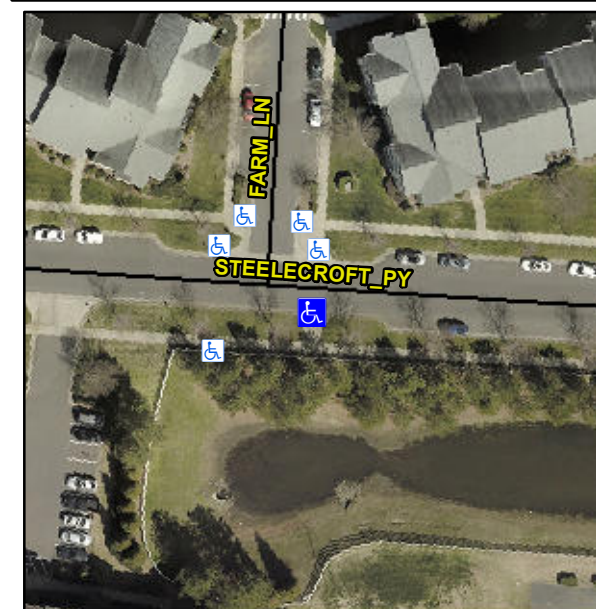
**Not Found, R304.5.1, R304.5.3**

Compliance	Description	Data	Compliance	Description	Data
N/A	Ramp Length (in)	84.0	Yes	Ramp Slope (%)	8.0
No	Ramp Width (in)	47.0	No	Ramp XSlope (%)	4.2
N/A	Flare Type LT	N/A	N/A	Flare Type RT	N/A
N/A	Flare Slope LT (%)	N/A	N/A	Flare Slope RT (%)	N/A
N/A	Flare Traversable LT?	N/A	N/A	Flare Traversable RT?	N/A
N/A	Landing Length (in)	N/A	N/A	DWS Provided?	N/A
N/A	Landing Width (in)	N/A	N/A	DWS Contrast?	N/A
N/A	Landing Slope (%)	N/A	N/A	DWS Length (in)	N/A
N/A	Landing X Slope (%)	N/A	N/A	DWS Full Width?	N/A
N/A	Landing Curb? (Y/N)	N/A	N/A	DWS Offset (in)	N/A
N/A	Shared Landing?	N/A			
N/A	Gutter Ponding?	N/A	N/A	Gutter Slope (%)	N/A
N/A	Gutter Lip Ht (in)	N/A	N/A	Gutter X Slope (%)	N/A
N/A	Painted X Walk1?	No	N/A	Painted X Walk2?	N/A
	X Walk 1 Direction	To N		X Walk 2 Direction	N/A
N/A	X Walk 1 Width (in)	N/A	N/A	X Walk 2 Width (in)	N/A
	X Walk 1 Slope (%)	2.9		X Walk 2 Slope (%)	N/A
	X Walk 1 X Slope (%)	0.9		X Walk 2 X Slope (%)	N/A

N/A	Ramp inside XWalk1?	N/A	N/A	Ramp inside XWalk2?	N/A
	Road Slope (%)	N/A	N/A	Clear Space?	N/A
	Road X Slope (%)	N/A	N/A	Clear Space to XWalk (in)	N/A
N/A	Any Obstructions?	N/A	N/A	Storm Grate/Utility Hazard?	N/A
	Obstruction Type			Storm Grate/Utility Type	
		N/A			N/A
			Yes	Surface Condition? (G/P)	Good

**Remove & Replace Entire Ramp.**

Total Cost: \$ 1850.00
