Access Compliance Report Public Rights-of-Way (Curb Ramps)

Intersection ID: 13156 Main Street: S TRYON ST **Cross Street: W CARSON BV** Location: NE ADA ID: 532726060E9D Ramp Type: Perp Initial Pass/Fail: Fail **Overall Compliance: No Severity Score:** 12.5

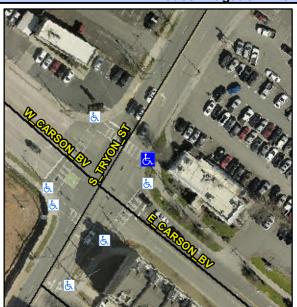
Comp	liance Description	Data	Comp	liance Description		
N/A	Ramp Length (in)	112.0	Yes	Ramp Slope (%)		
Yes	Ramp Width (in)	71.0	No	Ramp XSlope (%)		
N/A	Flare Type LT	N/A	N/A	Flare Type RT		
N/A	Flare Slope LT (%)	N/A	N/A	Flare Slope RT (%)		
N/A	Flare Traversable LT?	N/A	N/A	Flare Traversable RT?		
N/A	Landing Length (in)	N/A	N/A	DWS Provided?		
N/A	Landing Width (in)	N/A	N/A	DWS Contrast?		
N/A	Landing Slope (%)	N/A	N/A	DWS Length (in)		
N/A	Landing X Slope (%)	N/A	N/A	DWS Full Width?		
N/A	Landing Curb? (Y/N)	N/A	N/A	DWS Offset (in)		
N/A	Shared Landing?	N/A				
N/A	Gutter Ponding?	N/A	N/A	Gutter Slope (%)		
N/A	Gutter Lip Ht (in)	N/A	N/A	Gutter X Slope (%)		
N/A	Painted X Walk1?	Yes	N/A	Painted X Walk2?		
	X Walk 1 Direction	To NW		X Walk 2 Direction		
N/A	X Walk 1 Width (in)	113.0	N/A	X Walk 2 Width (in)		
	X Walk 1 Slope (%)	5.2		X Walk 2 Slope (%)		
	X Walk 1 X Slope (%)	1.3		X Walk 2 X Slope (%)		
N/A	Ramp inside XWalk1?	Yes	N/A	Ramp inside XWalk2?

Possible Solutions:						
Remove & Replace Entire Ramp.						
Surveyor Notes:						
N/A						
PROW/ADA:						
R304.5.3

ROW/ADA:			IN/A
R304.5.3			N/A
			N/A
			N/A
			N/A
- Total Cost:	\$	1850.00	N/A
J	*
