# Access Compliance Report

## Public Rights-of-Way

### (Curb Ramps)

Intersection ID: 10023377	Main Street: CHINA GROVE CHURCH RD	Cross Street: N/A	Location: NE
ADA ID: 532B7F2D05FA	Ramp Type: PerpDiag	Initial Pass/Fail: Fail	Overall Compliance: No
Codes/Mitigation Info/Possible Solution		Field Measurements/Component Compliance	
Severity Score: 8.75

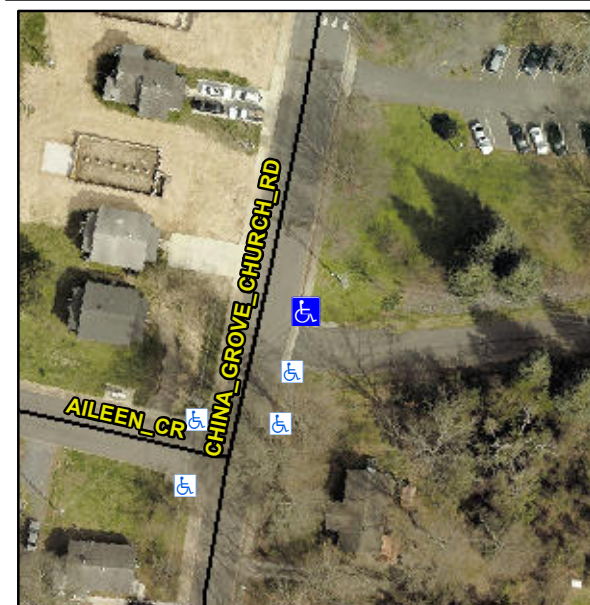
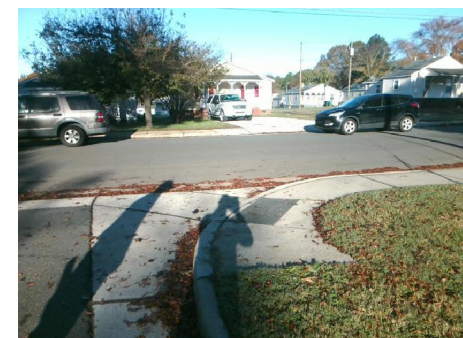
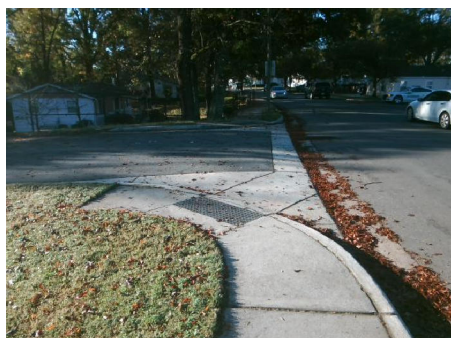
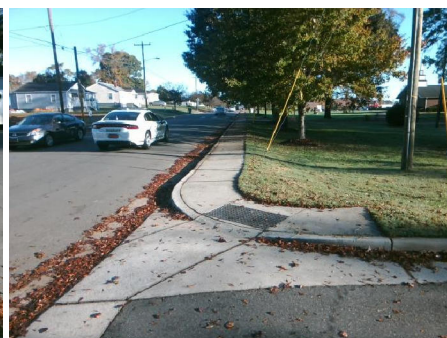
**Not Found, R304.5.1**

Compliance	Description	Data	Compliance	Description	Data
N/A	Ramp Length (in)	42.0	Yes	Ramp Slope (%)	7.1
No	Ramp Width (in)	47.0	Yes	Ramp XSlope (%)	0.8
N/A	Flare Type LT	N/A	N/A	Flare Type RT	N/A
N/A	Flare Slope LT (%)	N/A	N/A	Flare Slope RT (%)	N/A
N/A	Flare Traversable LT?	N/A	N/A	Flare Traversable RT?	N/A
N/A	Landing Length (in)	N/A	N/A	DWS Provided?	N/A
N/A	Landing Width (in)	N/A	N/A	DWS Contrast?	N/A
N/A	Landing Slope (%)	N/A	N/A	DWS Length (in)	N/A
N/A	Landing X Slope (%)	N/A	N/A	DWS Full Width?	N/A
N/A	Landing Curb? (Y/N)	N/A	N/A	DWS Offset (in)	N/A
N/A	Shared Landing?	N/A			
N/A	Gutter Ponding?	N/A	N/A	Gutter Slope (%)	N/A
N/A	Gutter Lip Ht (in)	N/A	N/A	Gutter X Slope (%)	N/A
N/A	Painted X Walk1?	No	N/A	Painted X Walk2?	No
	X Walk 1 Direction	To NW		X Walk 2 Direction	To SW
N/A	X Walk 1 Width (in)	N/A	N/A	X Walk 2 Width (in)	N/A
	X Walk 1 Slope (%)	4.4		X Walk 2 Slope (%)	0.3
	X Walk 1 X Slope (%)	1.2		X Walk 2 X Slope (%)	0.6

N/A	Ramp inside XWalk1?	N/A	N/A	Ramp inside XWalk2?	N/A
	Road Slope (%)	0.8	N/A	Clear Space?	N/A
	Road X Slope (%)	3.1	N/A	Clear Space to XWalk (in)	N/A
N/A	Any Obstructions?	N/A	N/A	Storm Grate/Utility Hazard?	N/A
	Obstruction Type			Storm Grate/Utility Type	
		N/A			N/A
			Yes	Surface Condition? (G/P)	Good

**Remove & Replace Curb Ramp With Two New Directional Ramps or Equivalent.**
